# RV Inspection Report

2022 Forest River Avalanche

**Inspection Date / RV Model:  
2022 Keystone Avalanche 390DS**

TNT RV Inspections

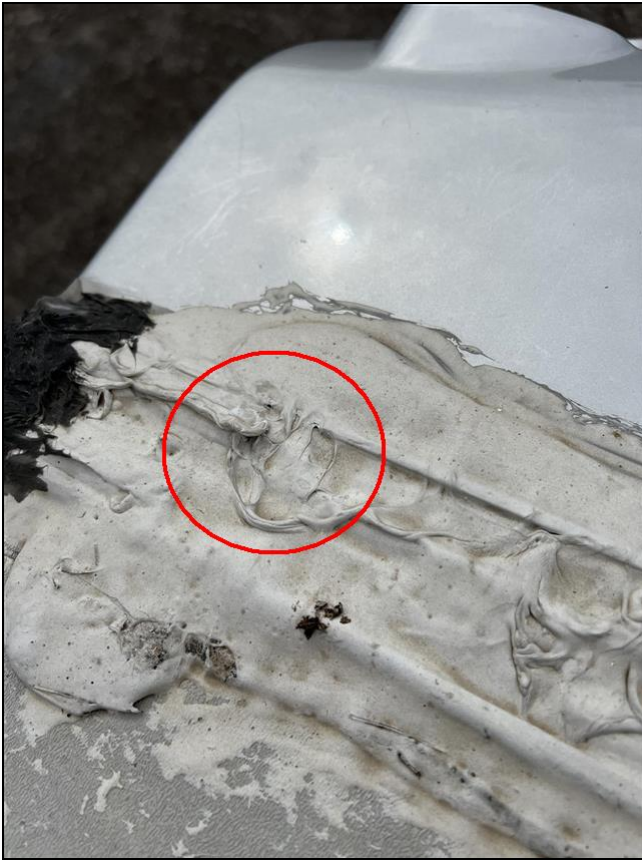
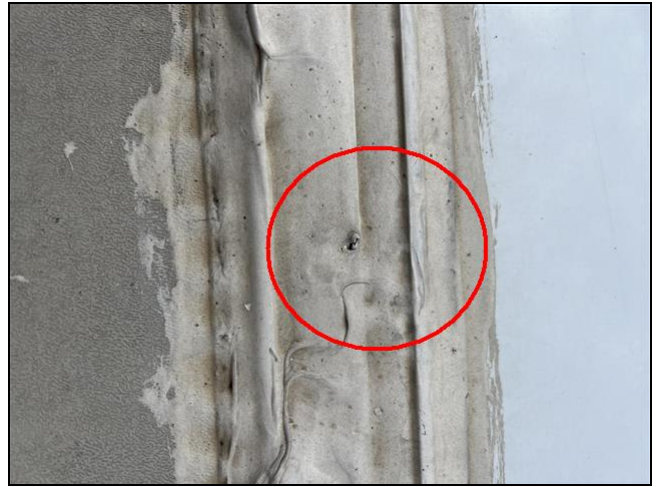
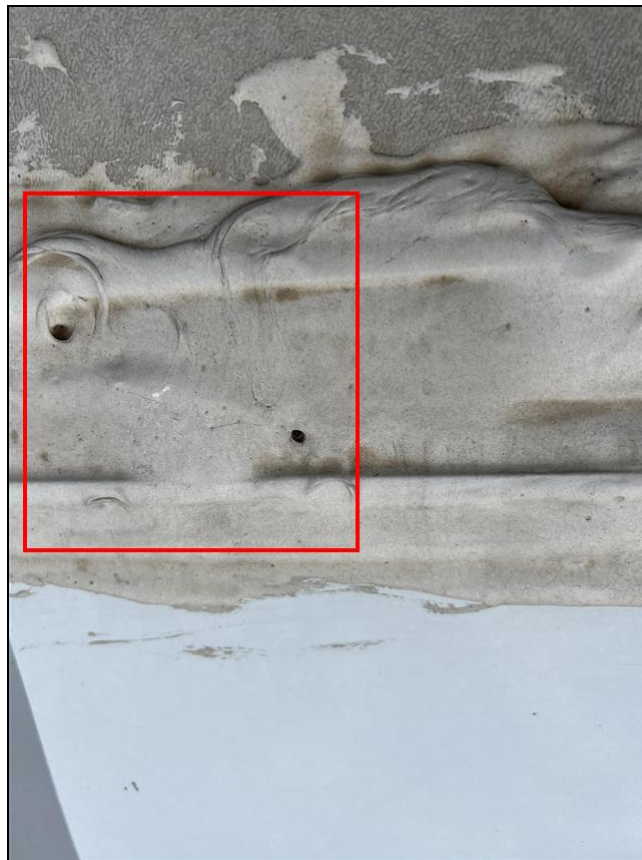
\$ (1) There are holes in the sealant in numerous places along the front cap that should be repaired to prevent water intrusion.

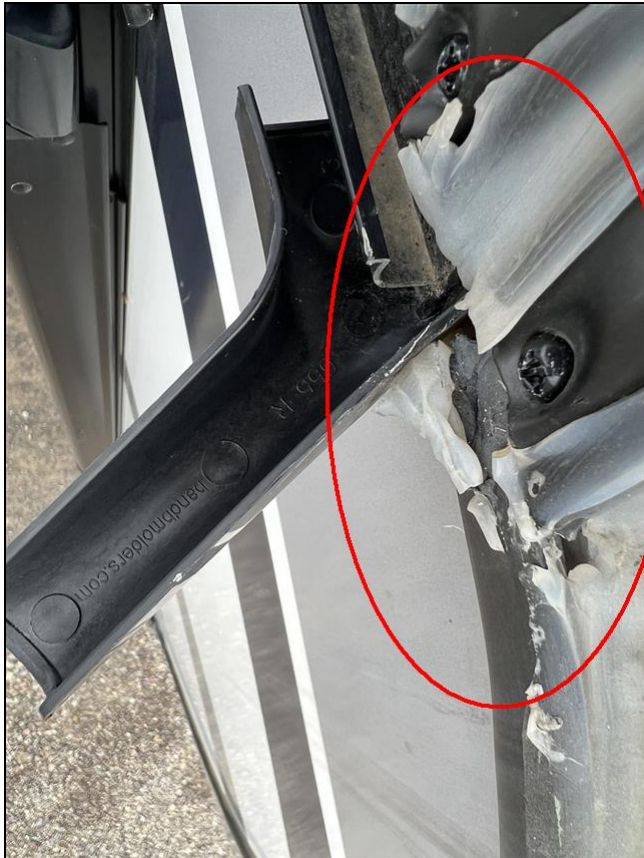
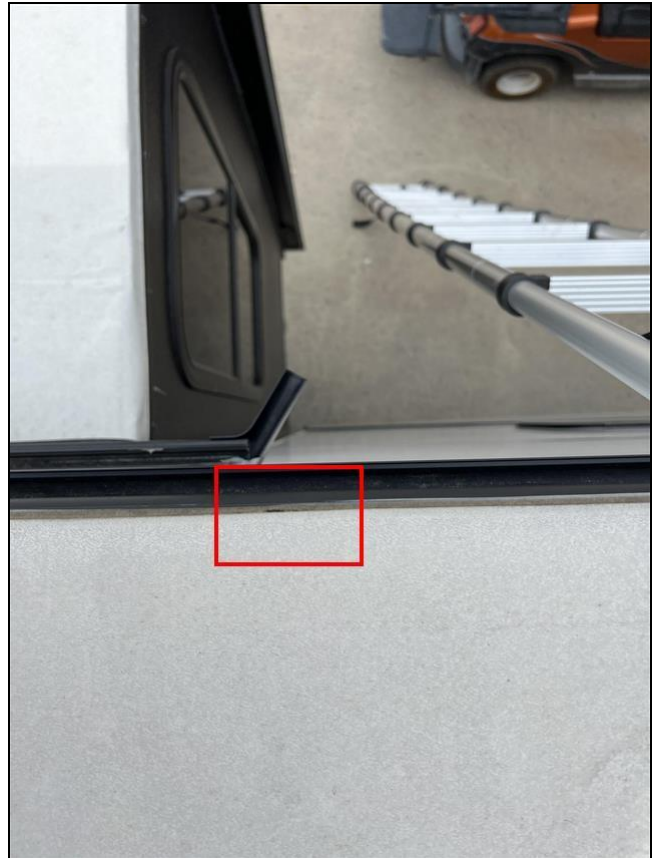
(2) Holes in sealant that have been repaired previously need to be looked at further by a certified RV Technician.

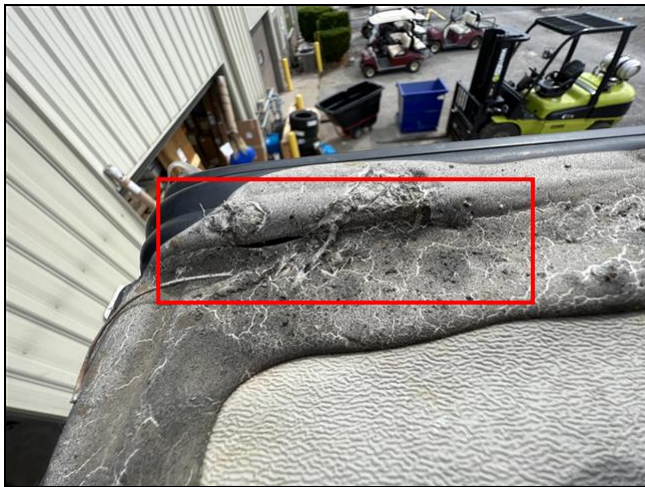
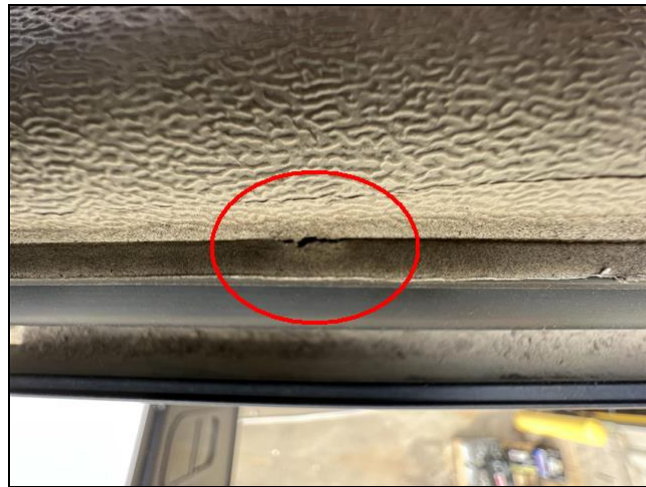
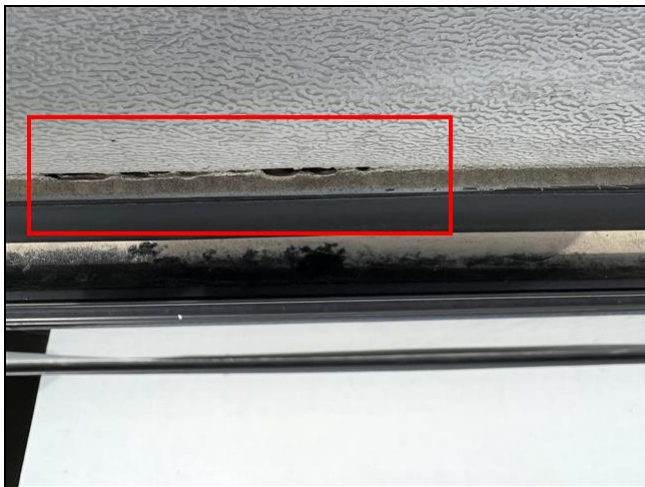
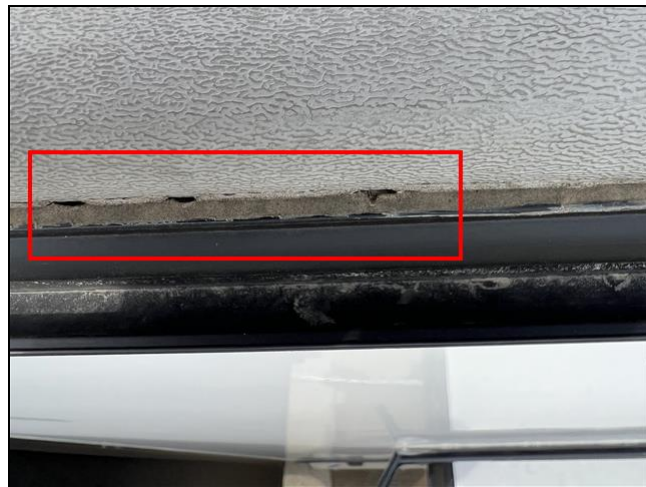
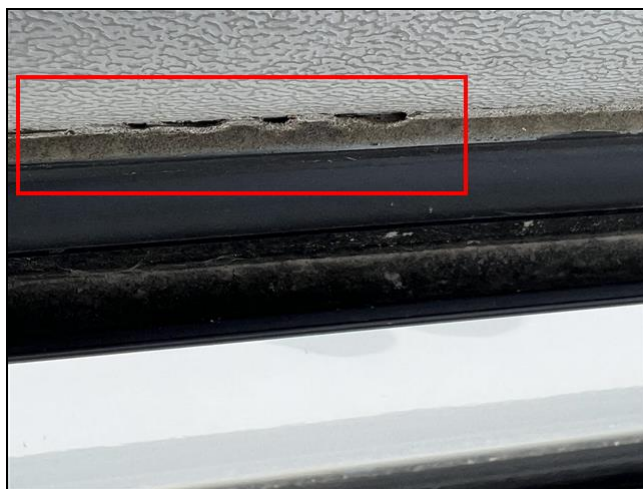
(2) There are several holes in sealant along the trim rail that need to be repaired to prevent water intrusion.

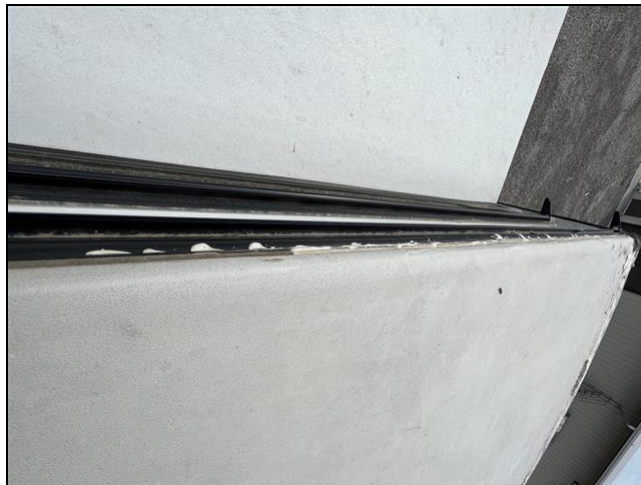
(3) New sealant repairs made to the trim rail.

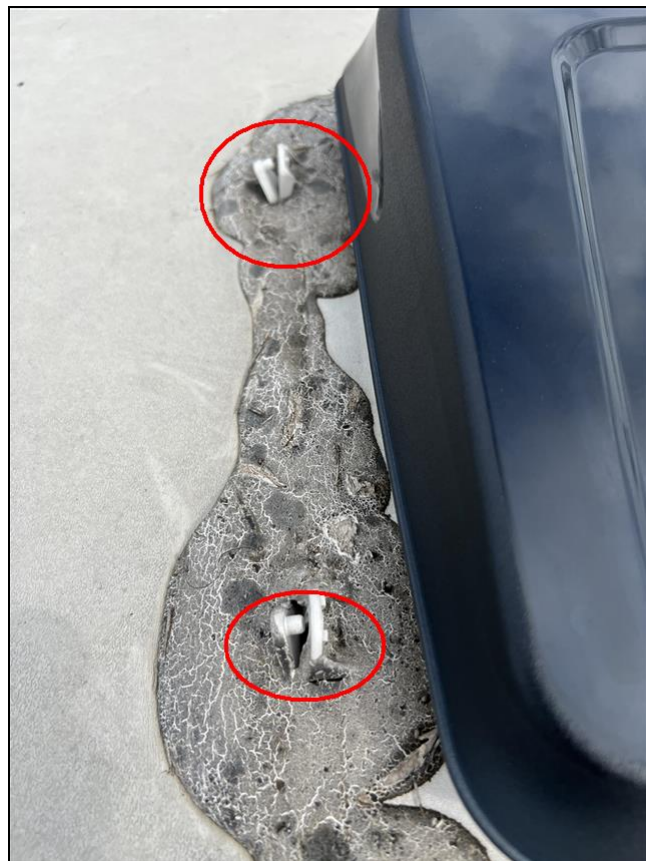
(1) The clips on the vent looked as though they are not attached and sealant was placed over them.

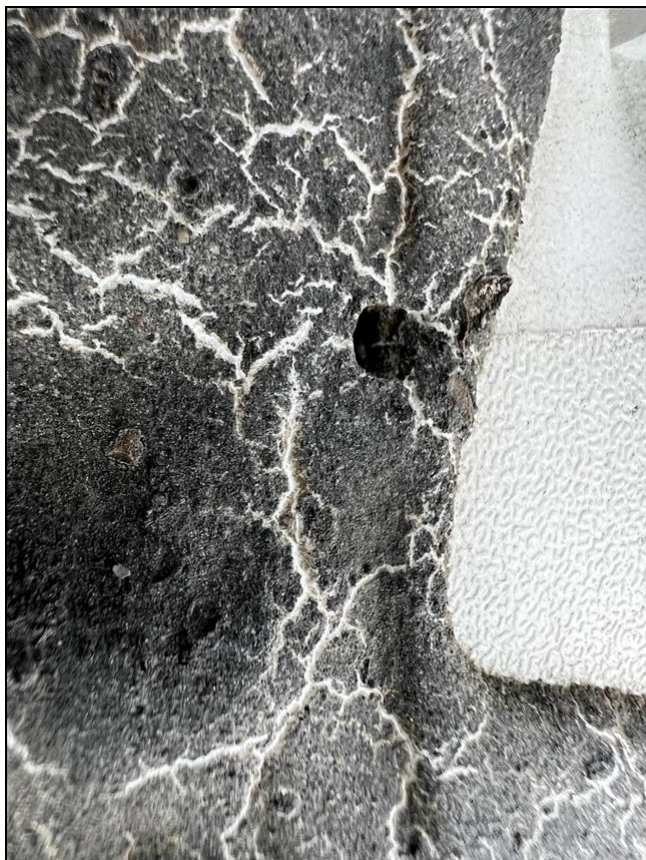
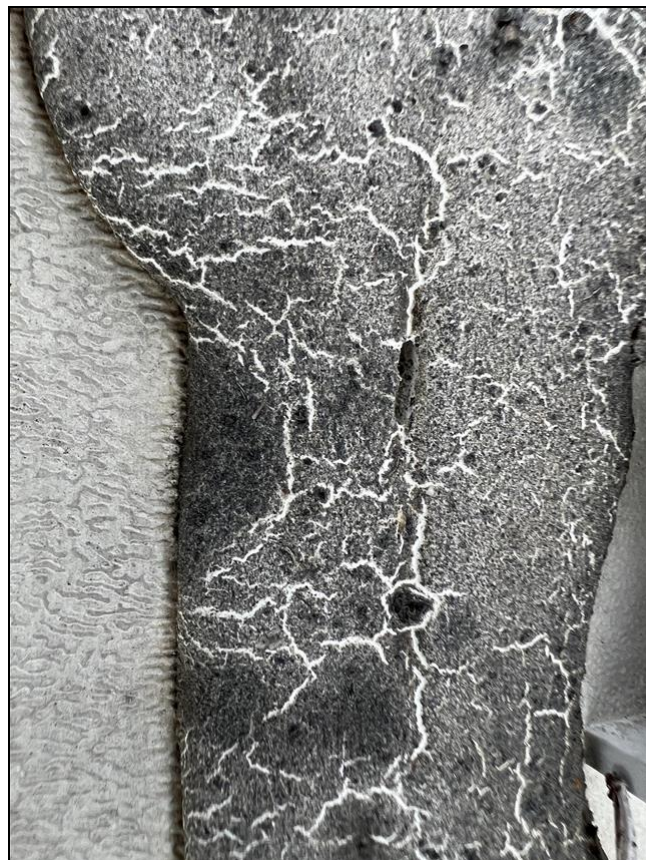
(3) Holes in sealant.

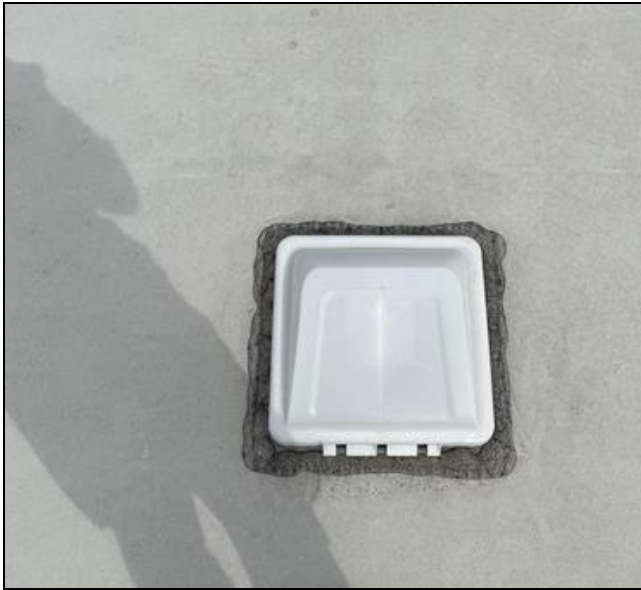
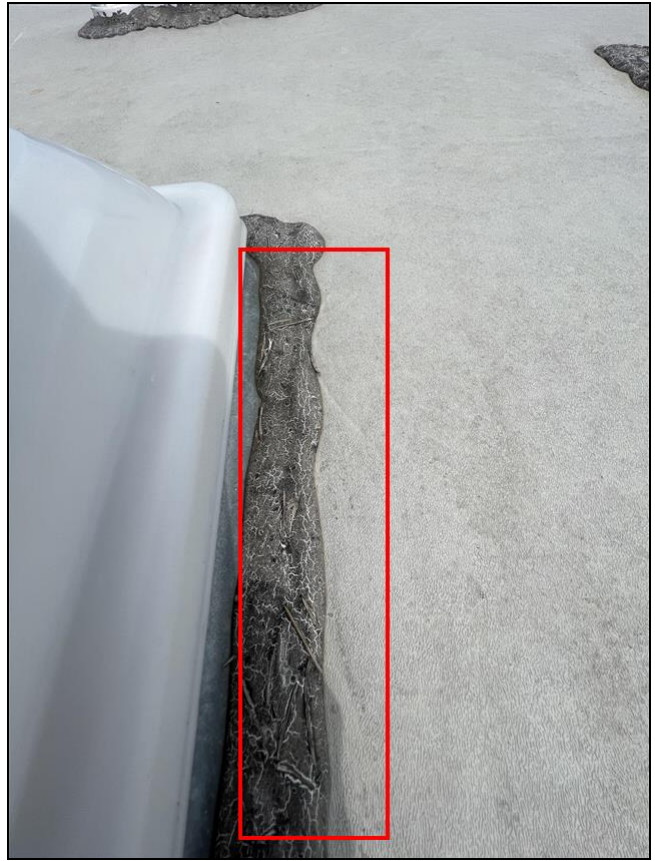
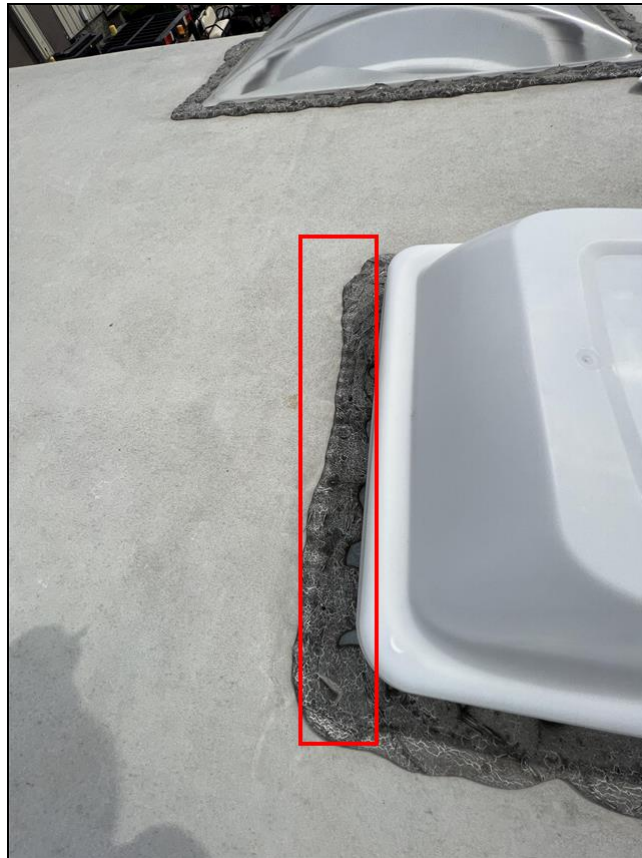
Pines needles embedded in the sealant around the vent.

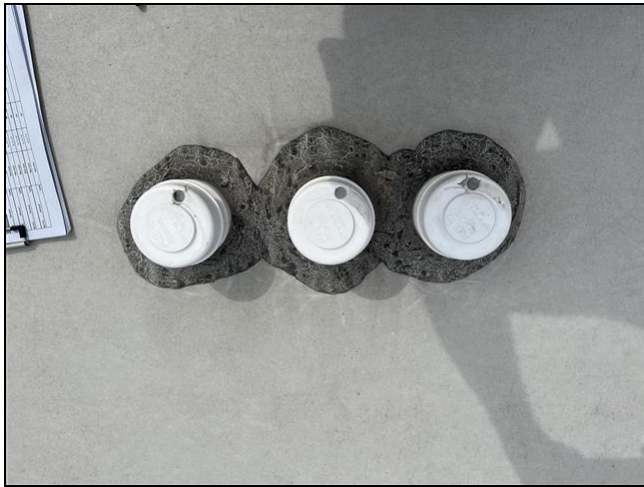
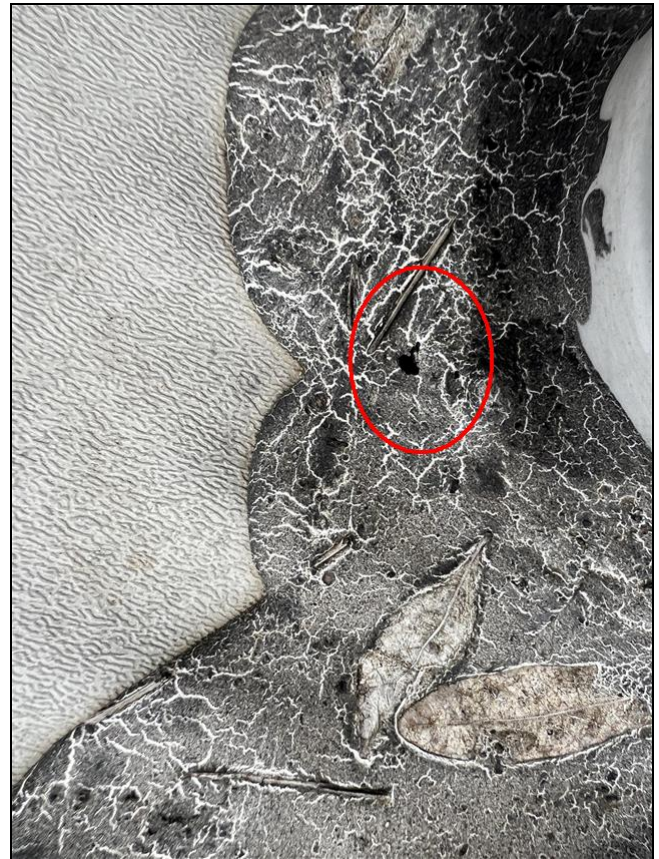
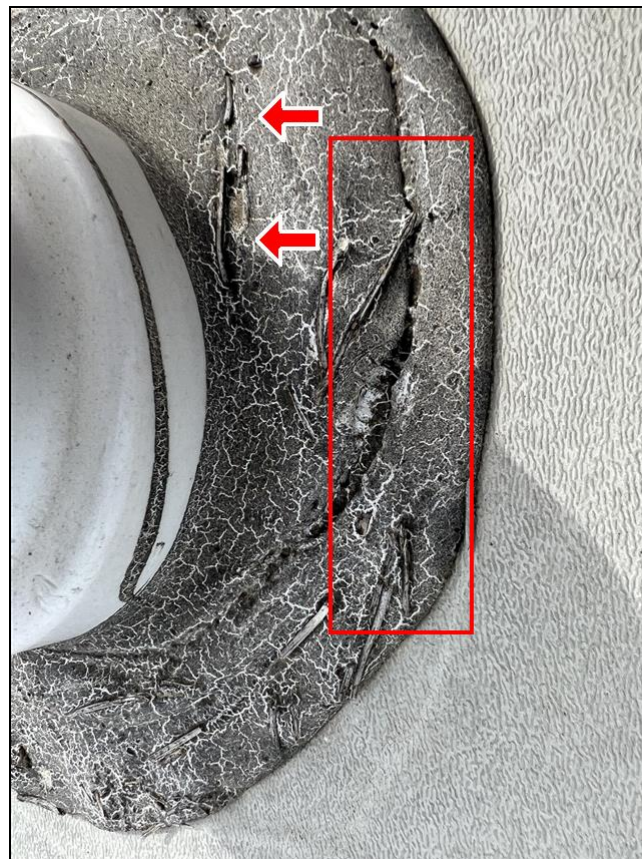
Front 3 covers

**\$** (1) There are holes and cracks around the line of three plumbing covers and should be repaired before water intrusion occurs.

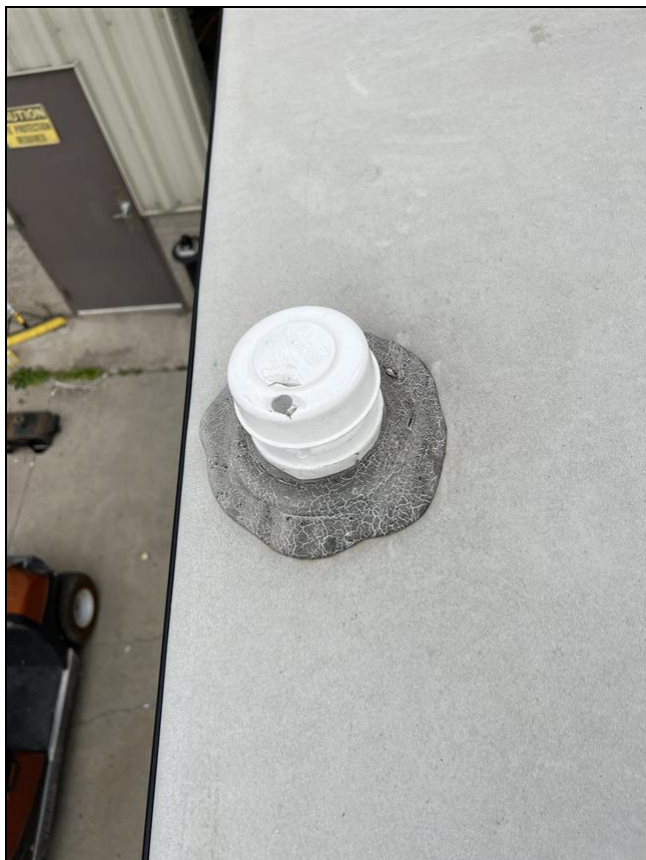
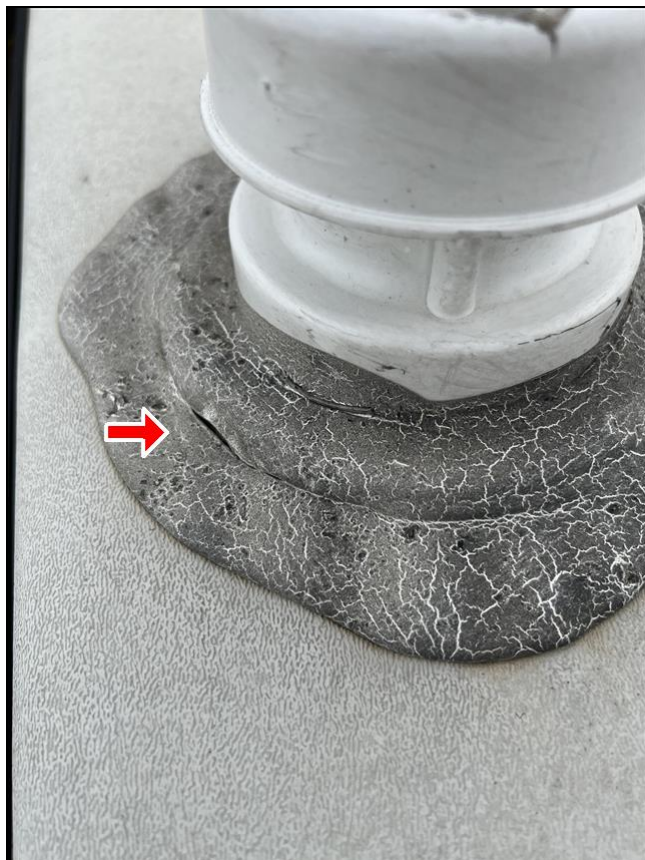
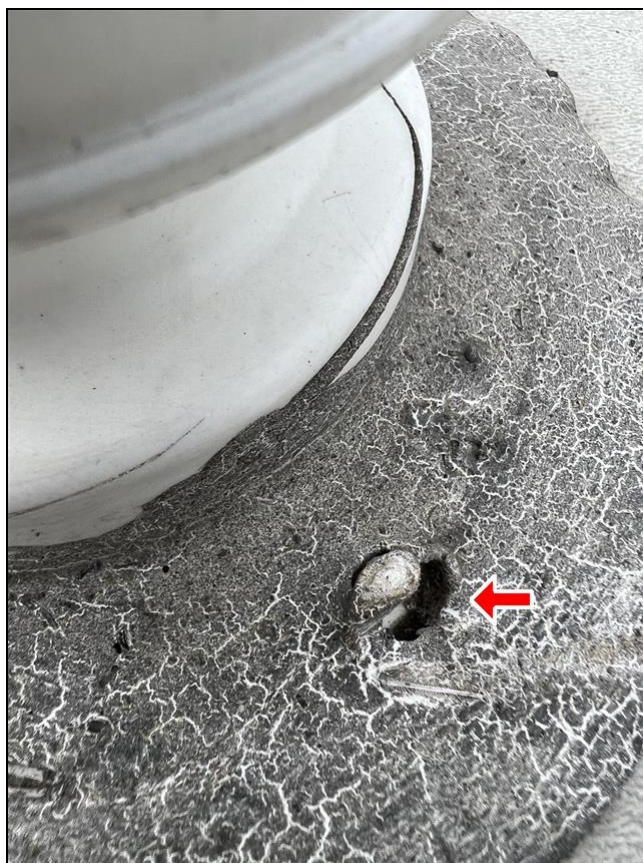
(2) Holes in sealant on the rear curbside plumbing vent cover should be repaired before water intrusion occurs.

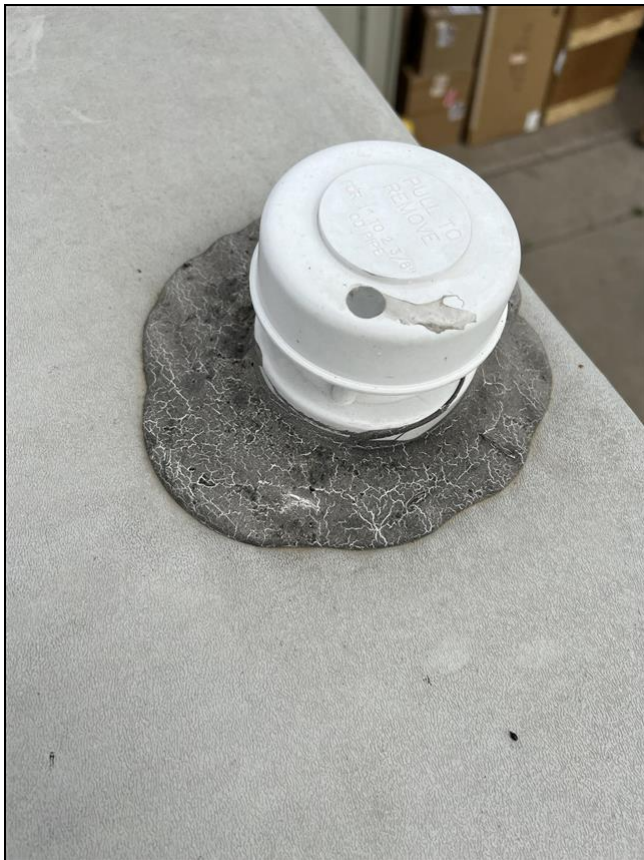
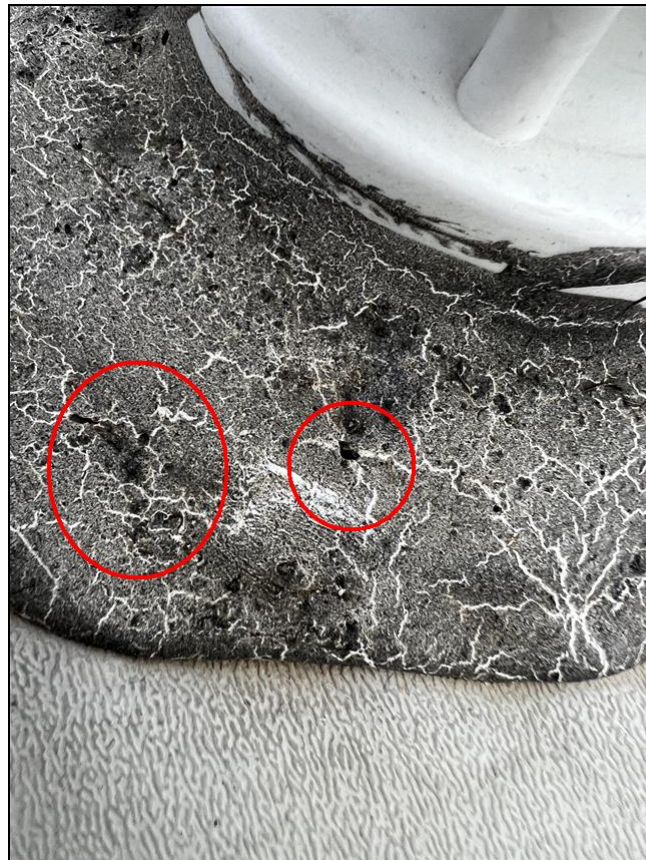
(3) Holes in the sealant around the streetside plumbing vent cover and should be repaired before water intrusion occurs.

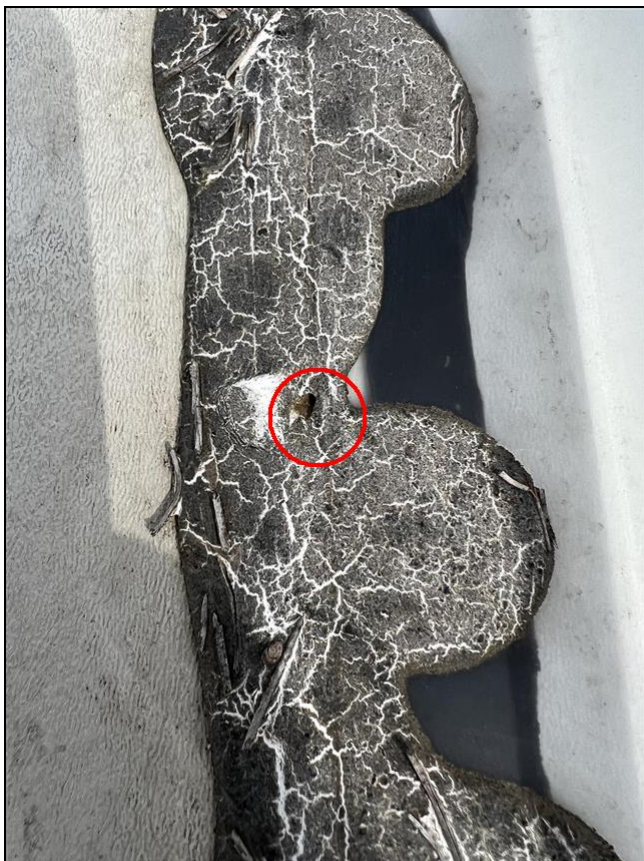
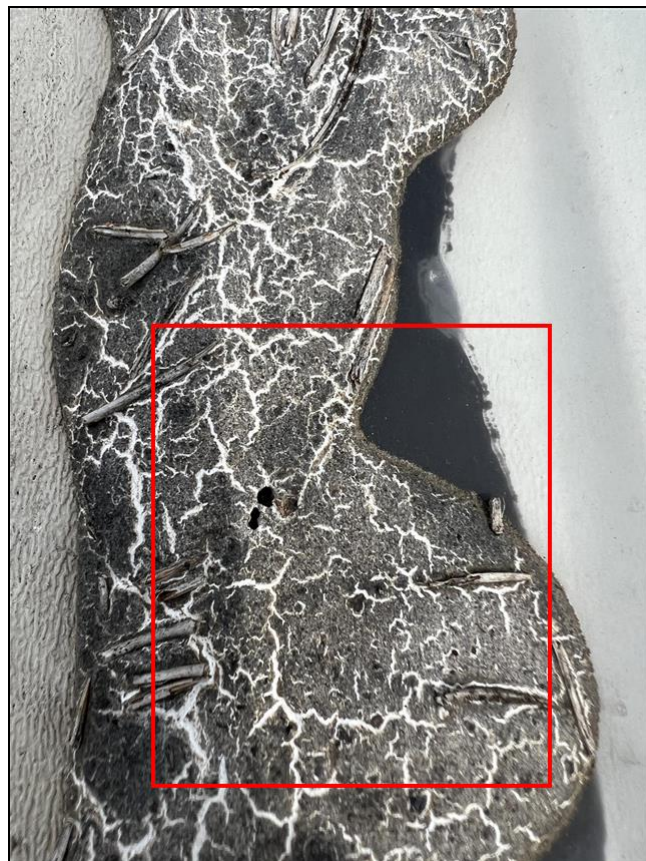
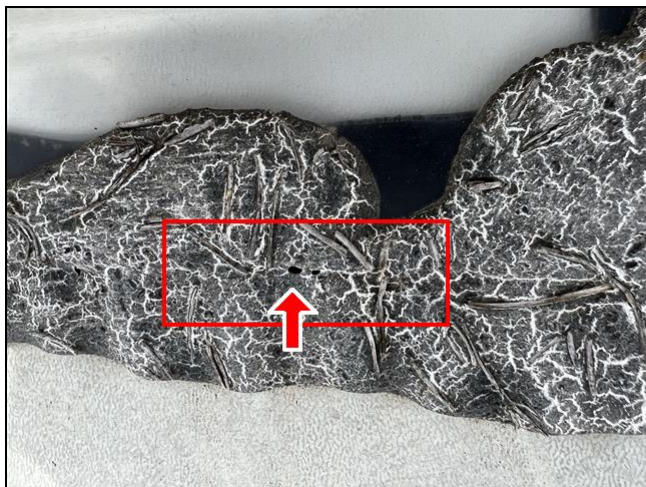
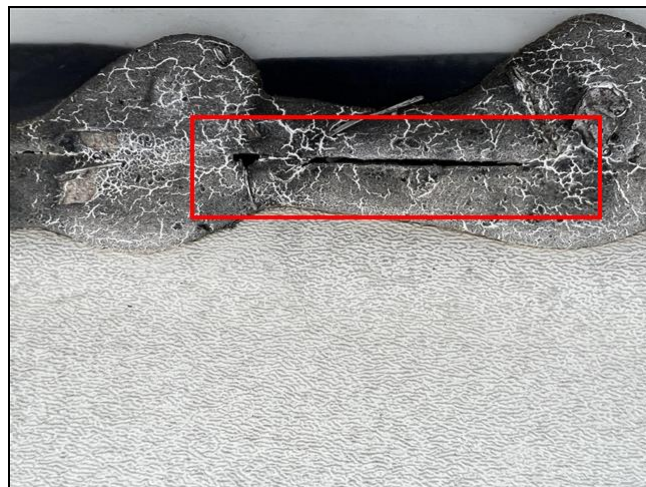
Holes and cracks in sealant around the skylight and should be repaired before water intrusion occurs.

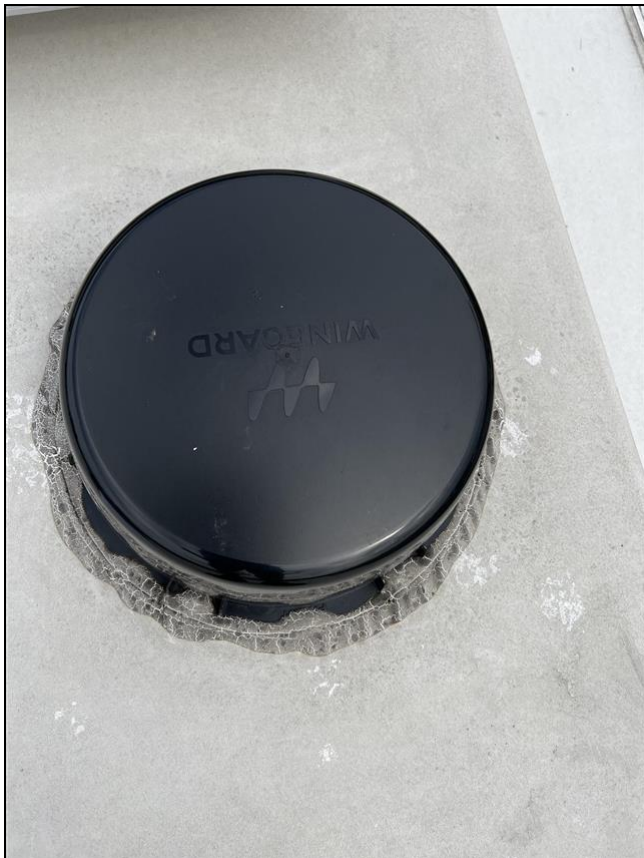
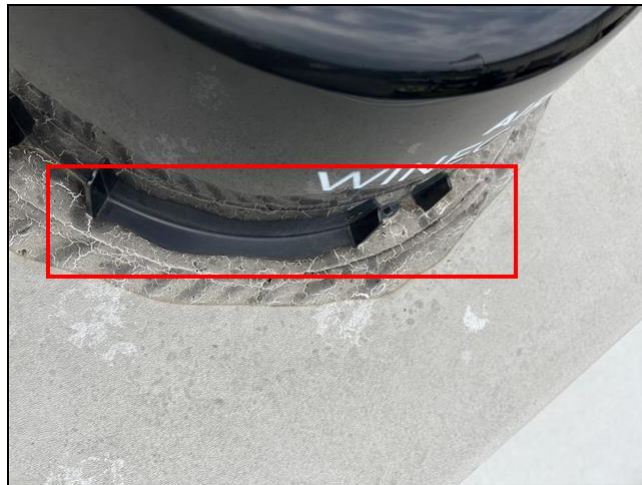
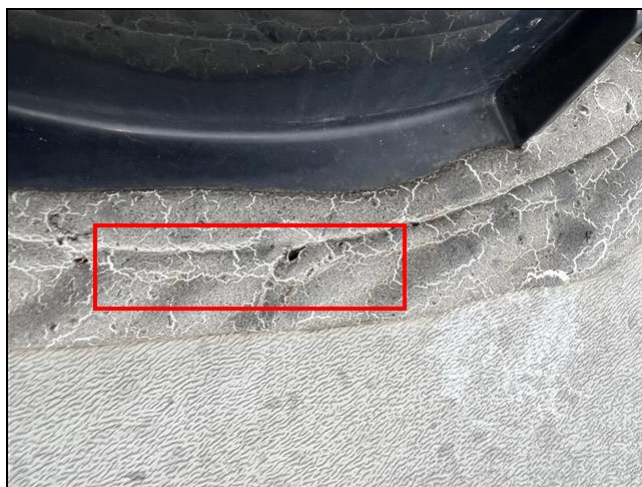
Holes in sealant around antenna that should be repaired before water intrusion occurs.

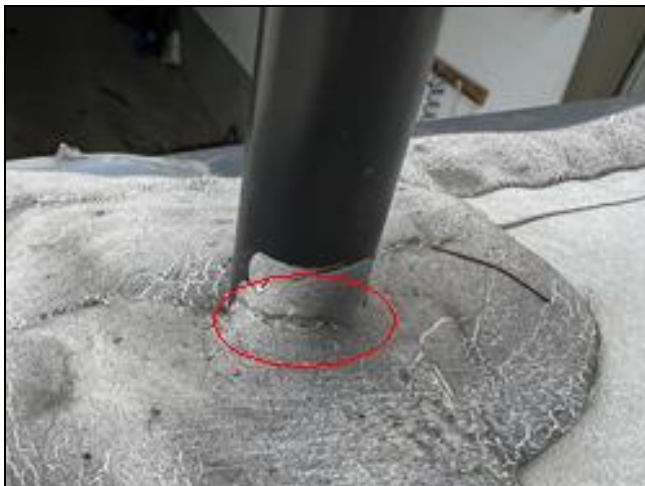
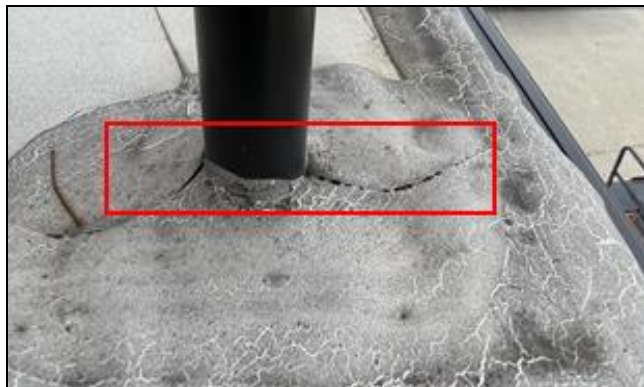
**\$** Cracks in sealant where ladder attaches to the roof and should be repaired before water intrusion occurs.

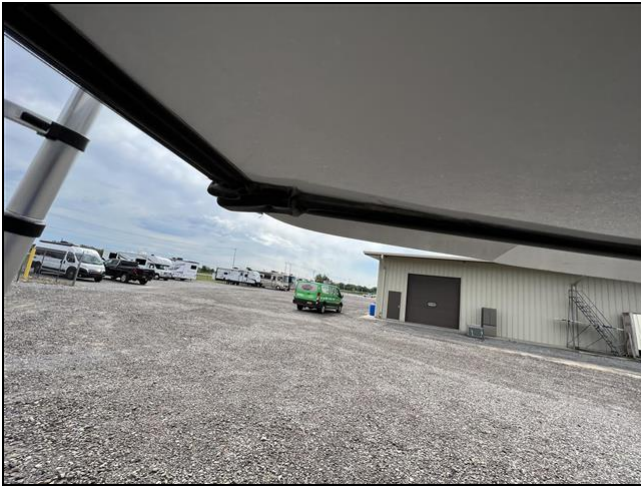
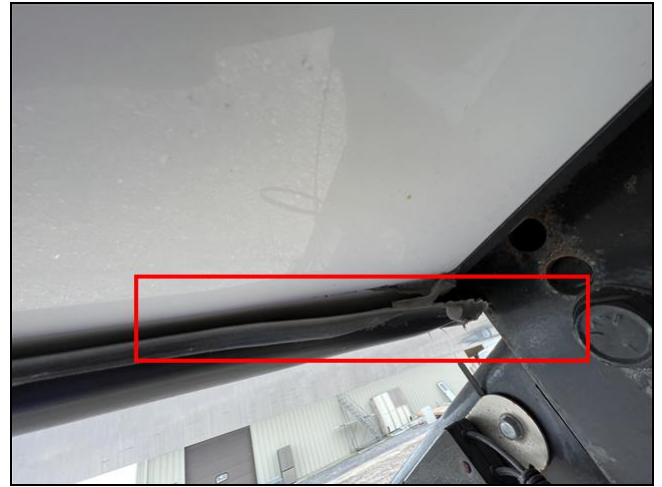
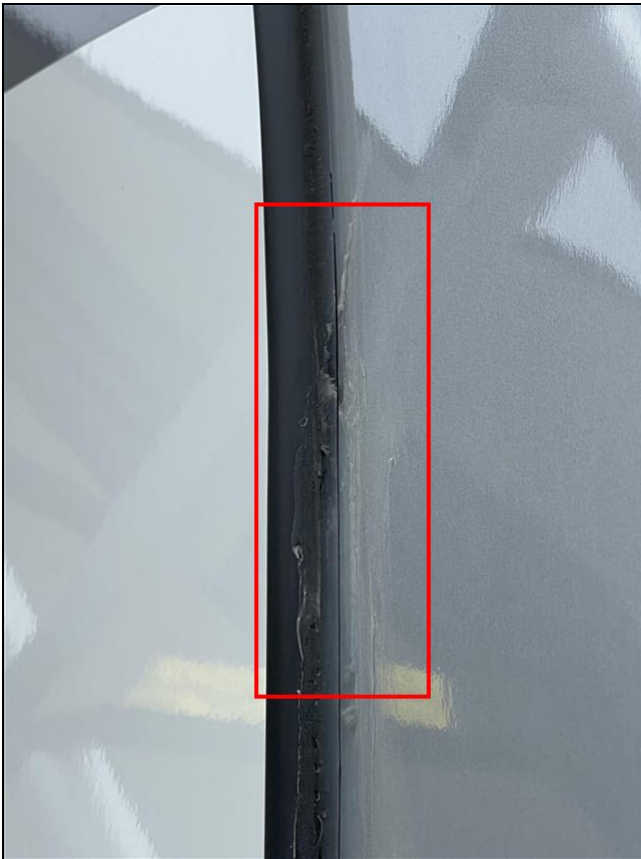
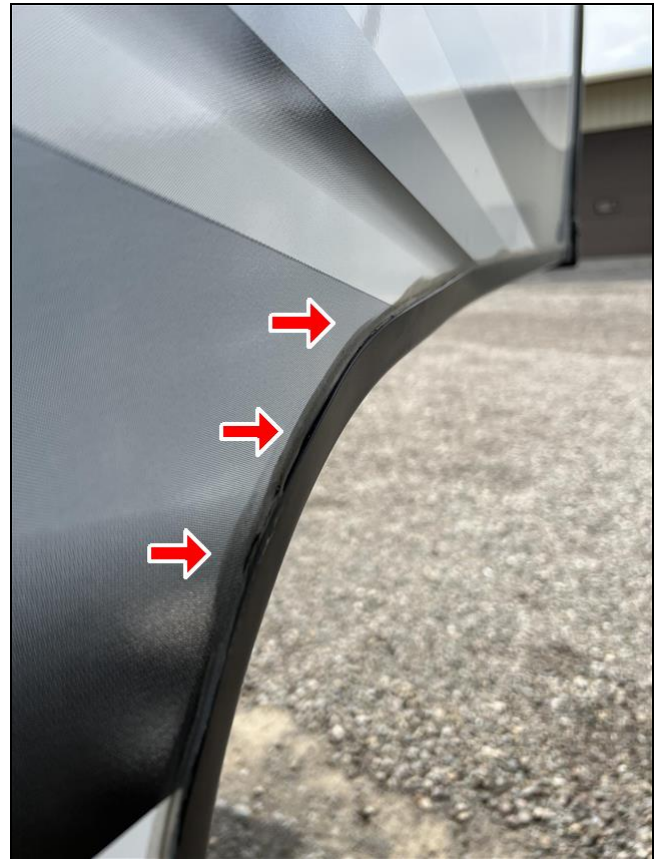
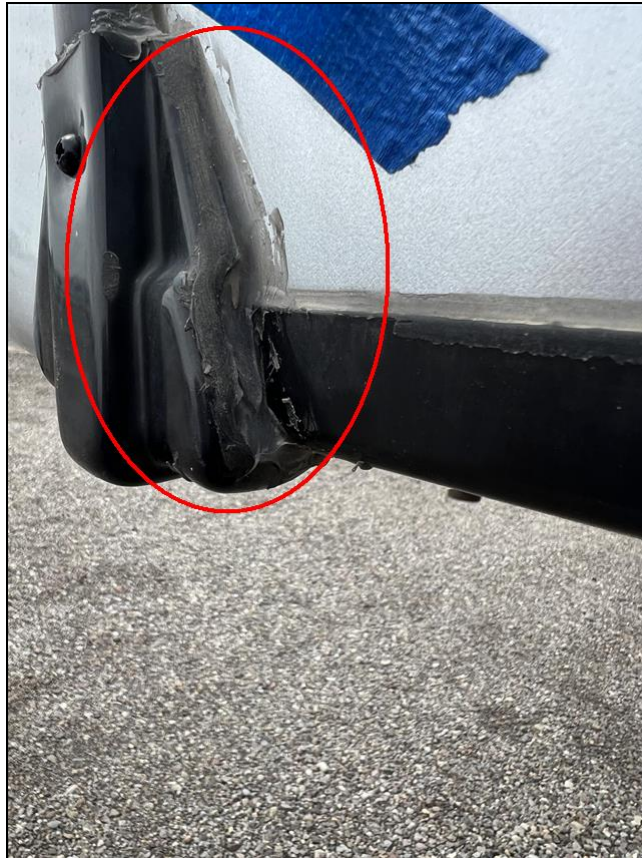
Streetside

**\$** (1) Seal that runs along the lower edge of cap just before hitch pin is torn. There is sealant missing along the curbside and streetside edge. These items should be repaired before water intrusion occurs. The lower seal on the streetside of the cap looks as though the sealant was repaired

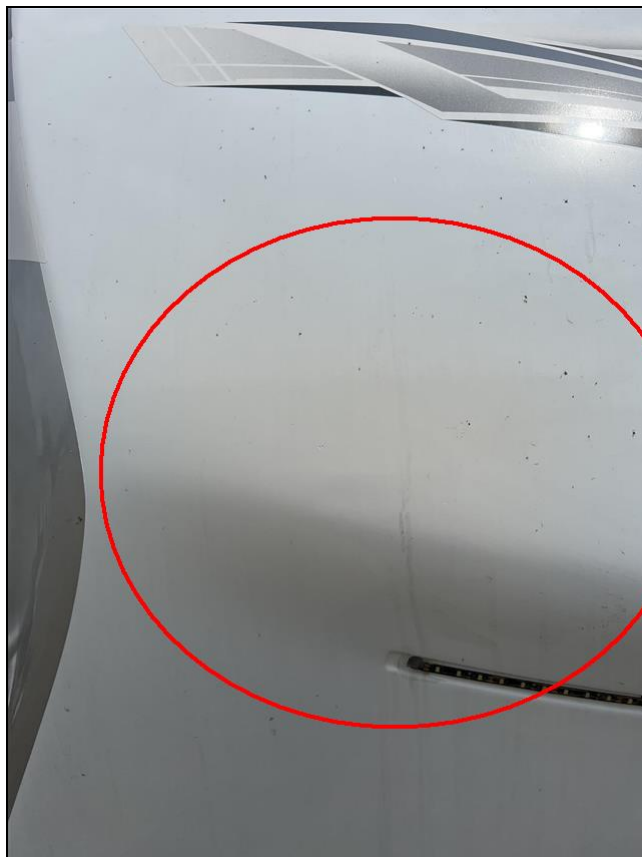
(2) On the curbside, there is a brown stain in the gel coat.

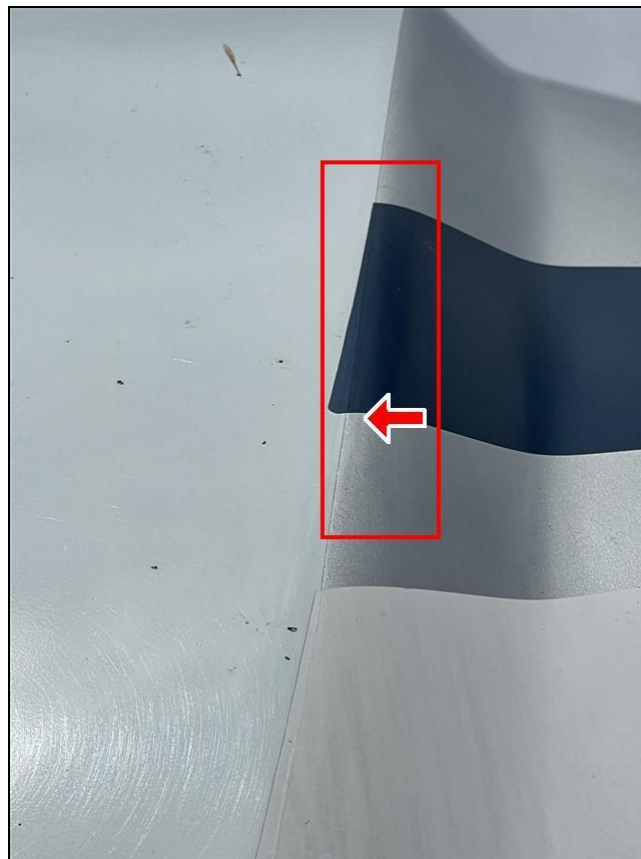
(1) Decal edge not lined up with other decals.

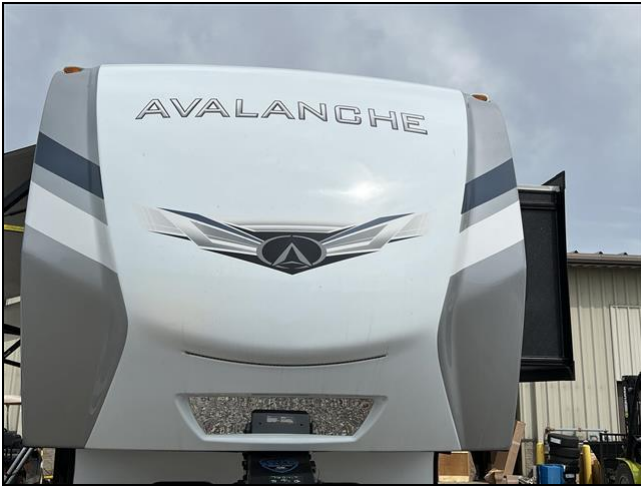
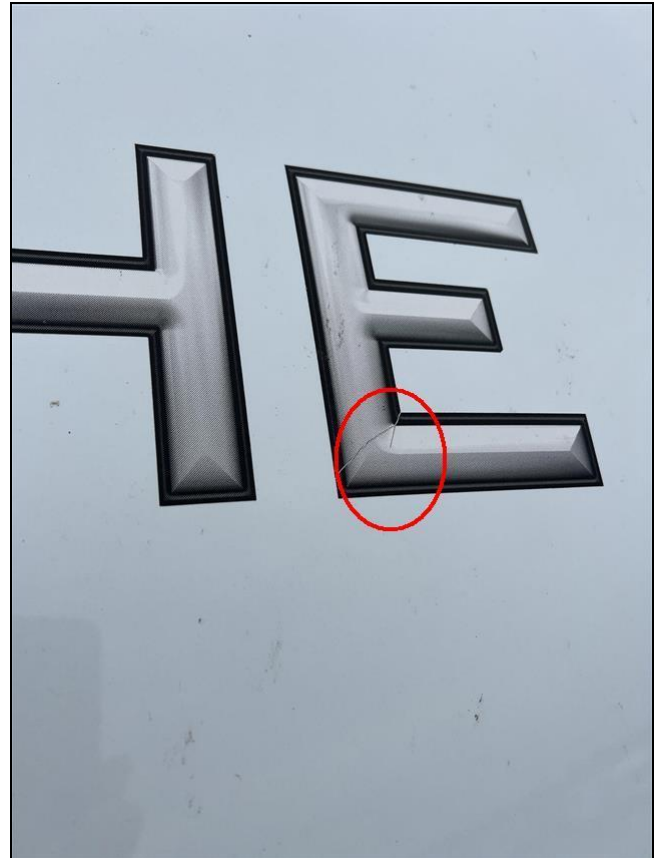
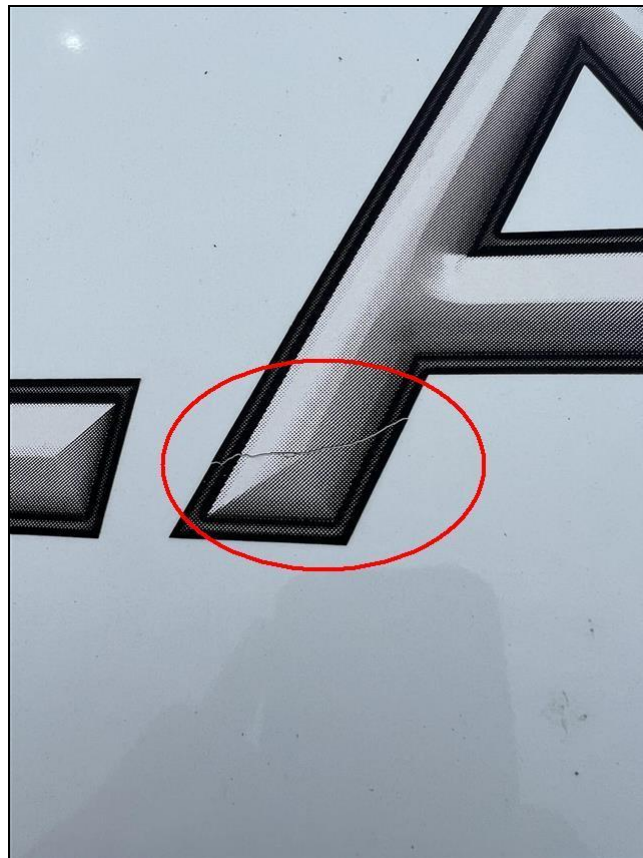
(2) Cracks in the lettering.

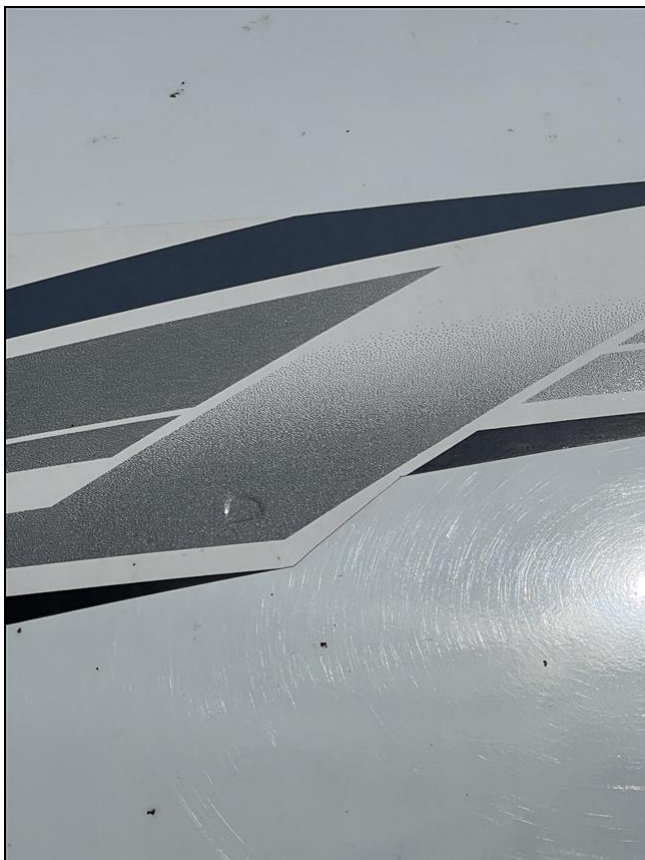
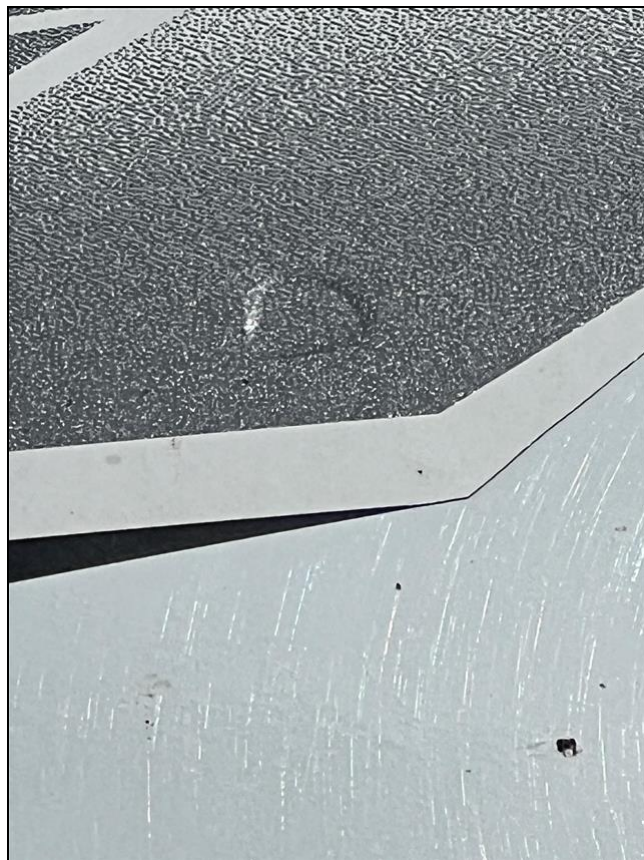
(3) Defect in the decal.

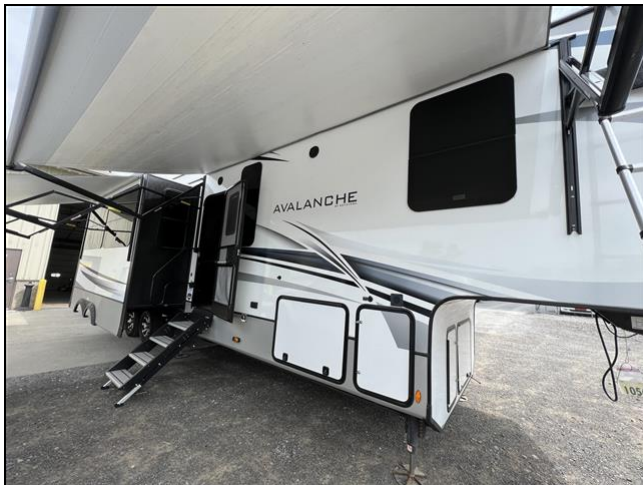
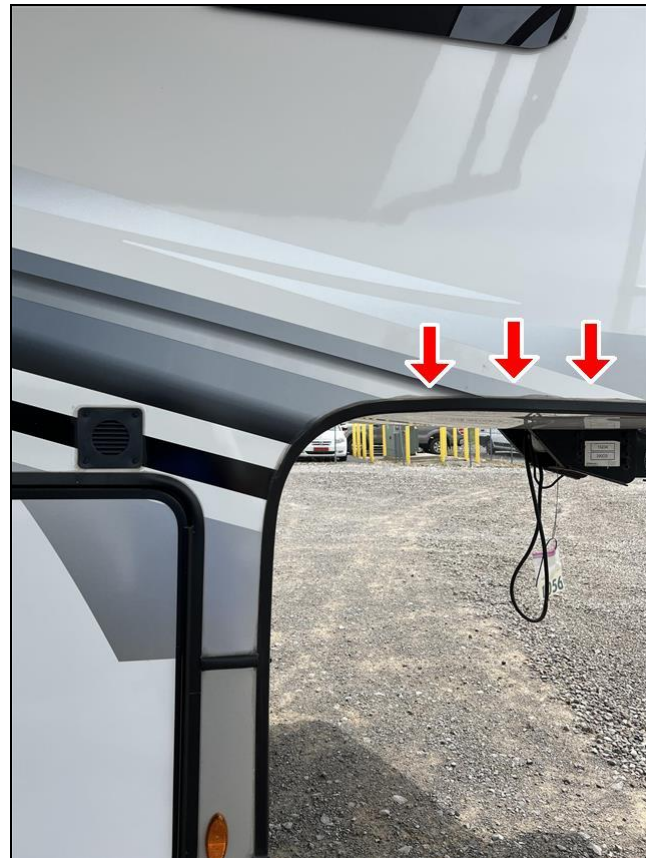
(1) Front seal is becoming detached and is in need of repair.
