# RV Inspection Report

2022 Forest River Avalanche

**Inspection Date / RV Model:  
2022 Keystone Avalanche 390DS**

TNT RV Inspections

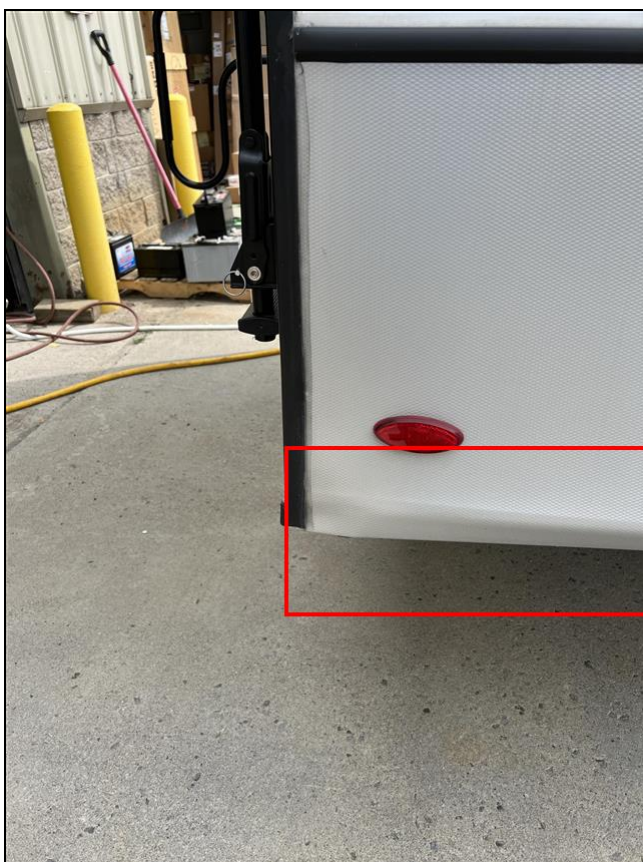
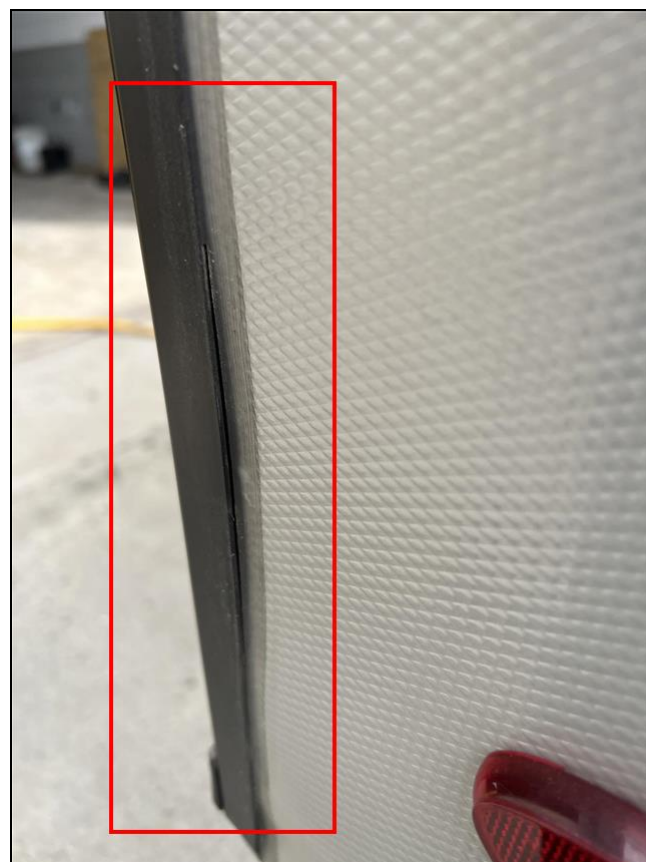
(2) There is damage to the rear lower edge of sidewall.

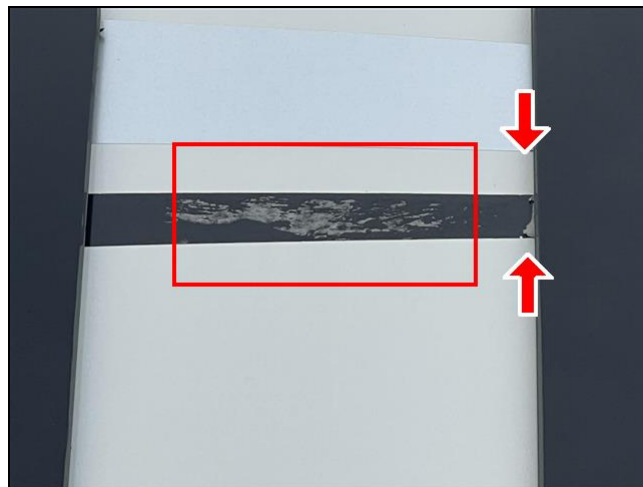
There is damage to the decal that is between the two rear windows.

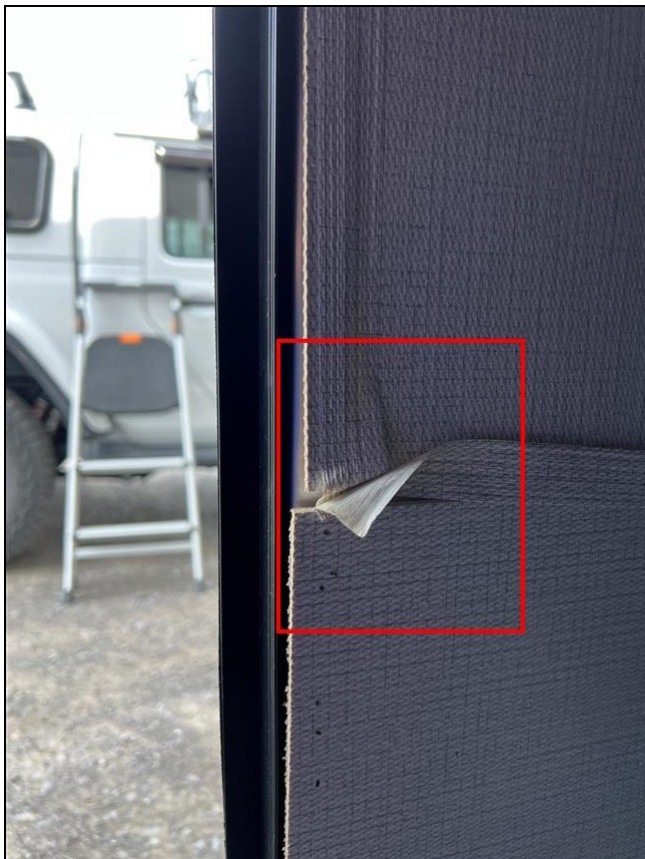
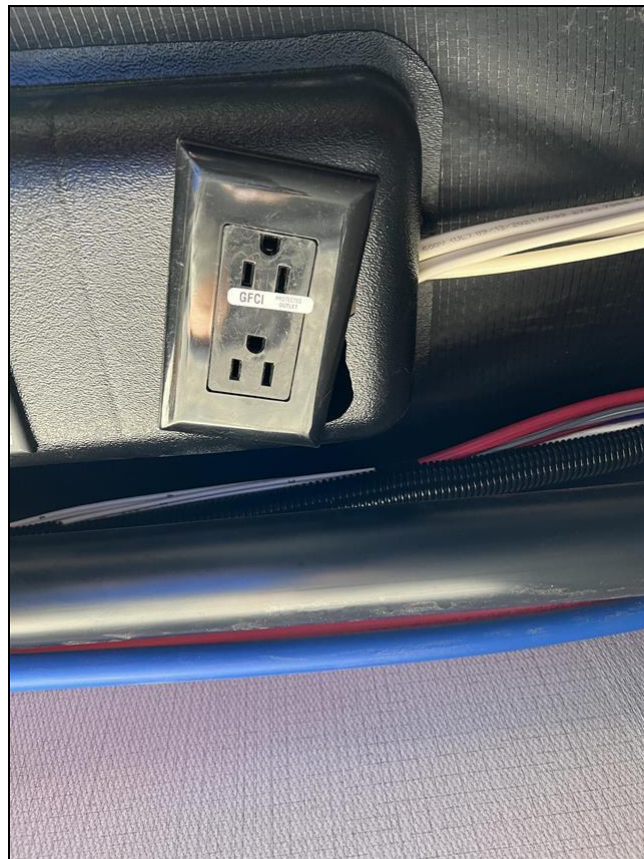
Inside the larger front cargo area the material on the side wall is coming off. There is also an electrical box that is not properly installed and should be repaired by a certified RV Technician.

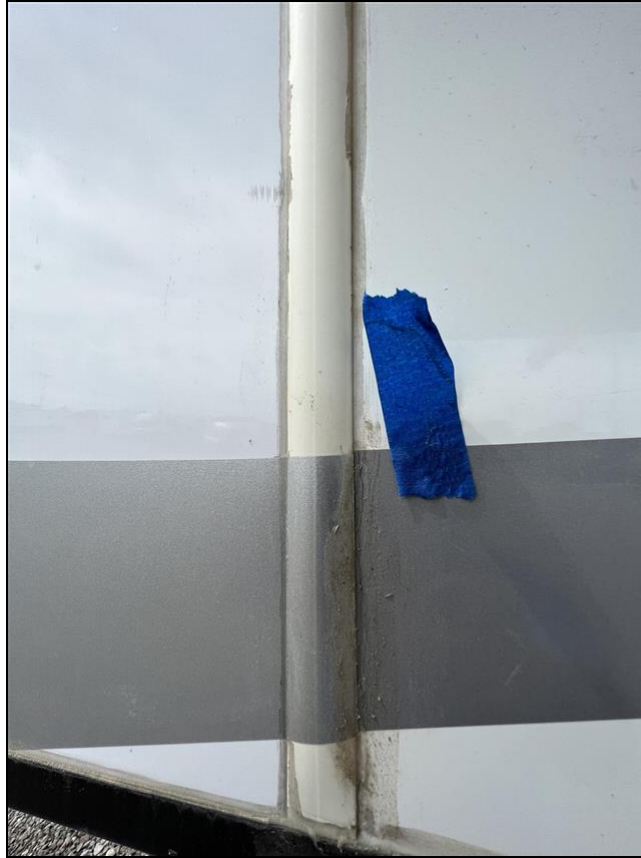
(1) Lower seam where sidewall meets the front cap the sealant is deteriorating.

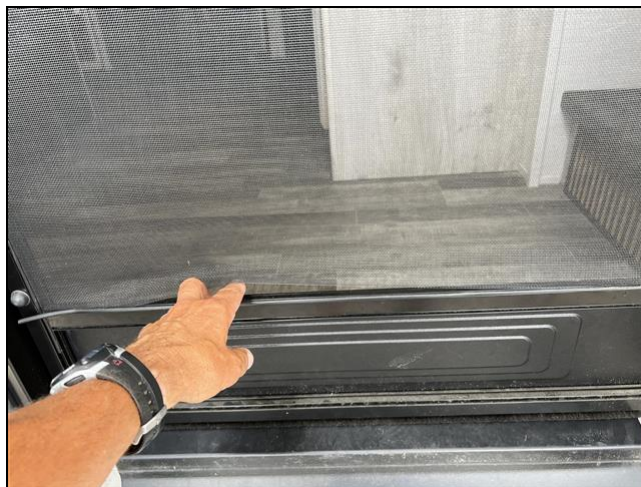
- 4.0.A Door Condition  
Comments: Fair  
The screen on the lower edge of screen door is separating.

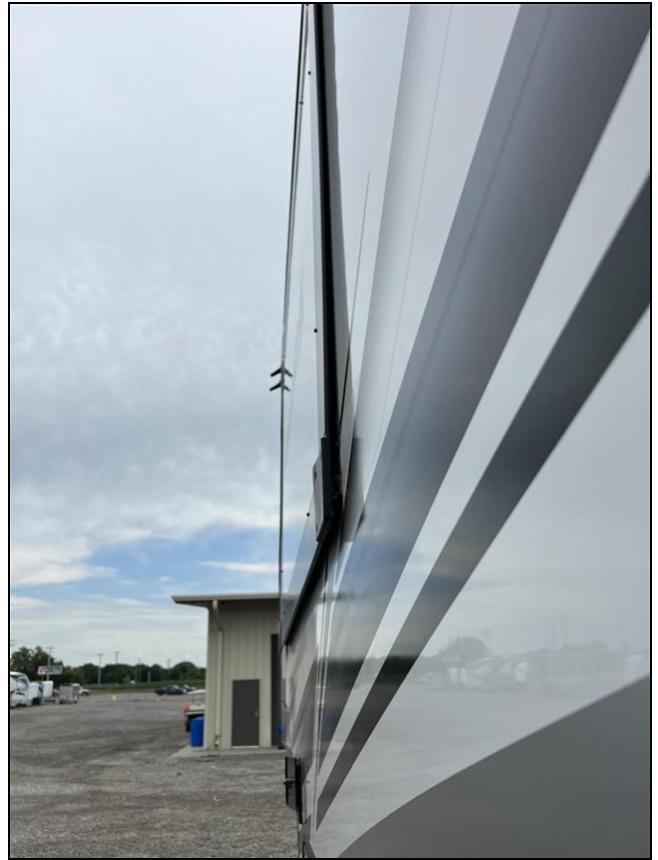
The lower front and rear of the slide out are not touching side wall. It appears that the slide box is warped.

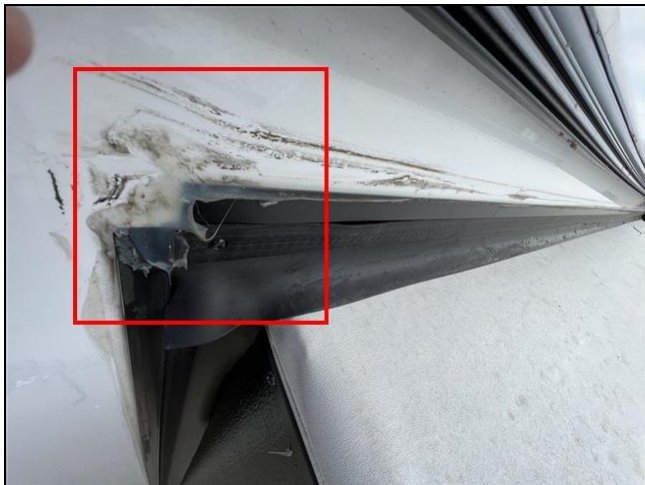
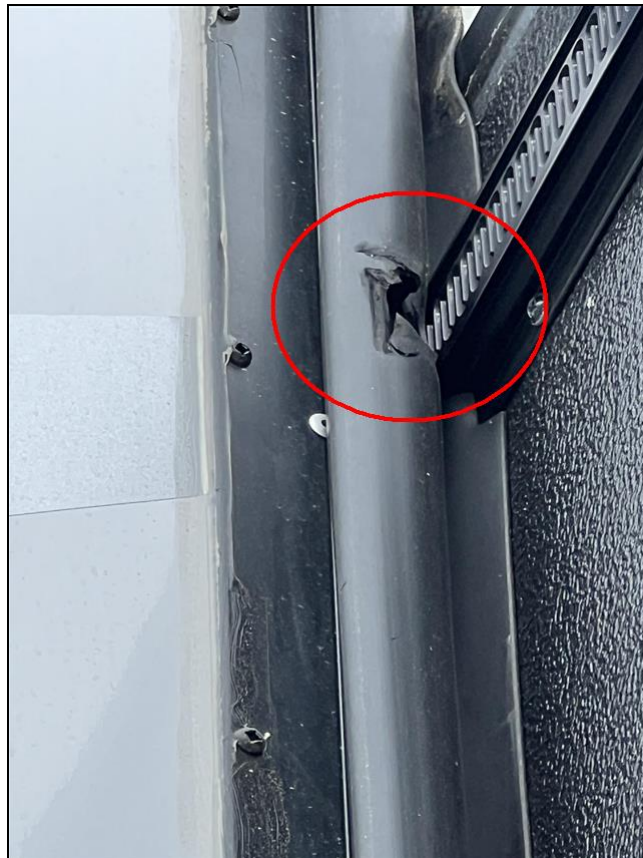
Front upper sweep has been repair. The left side seal has a hole in it where the upper gear track goes through it. This needs to be repaired before water intrusion occurs.

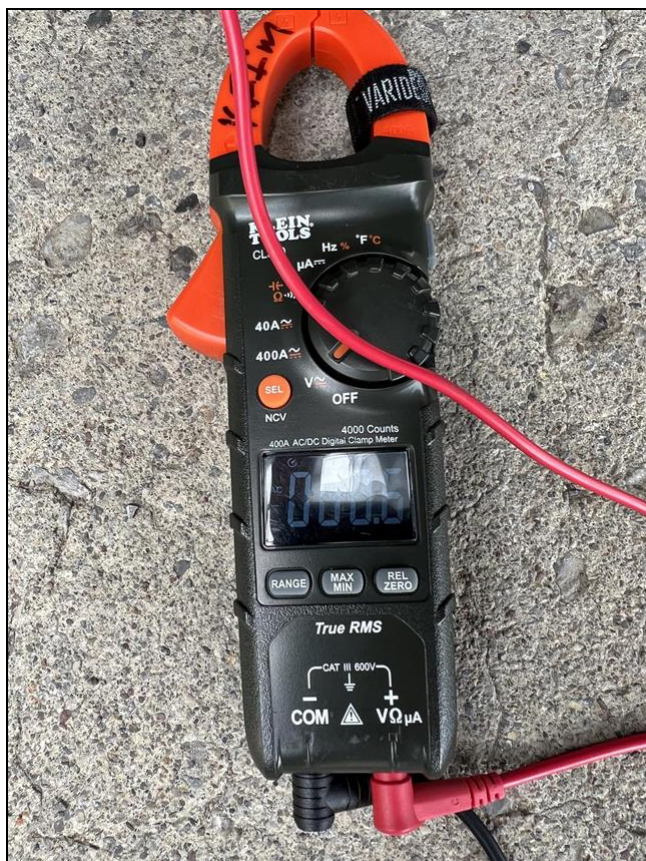
Volts recorded on frame

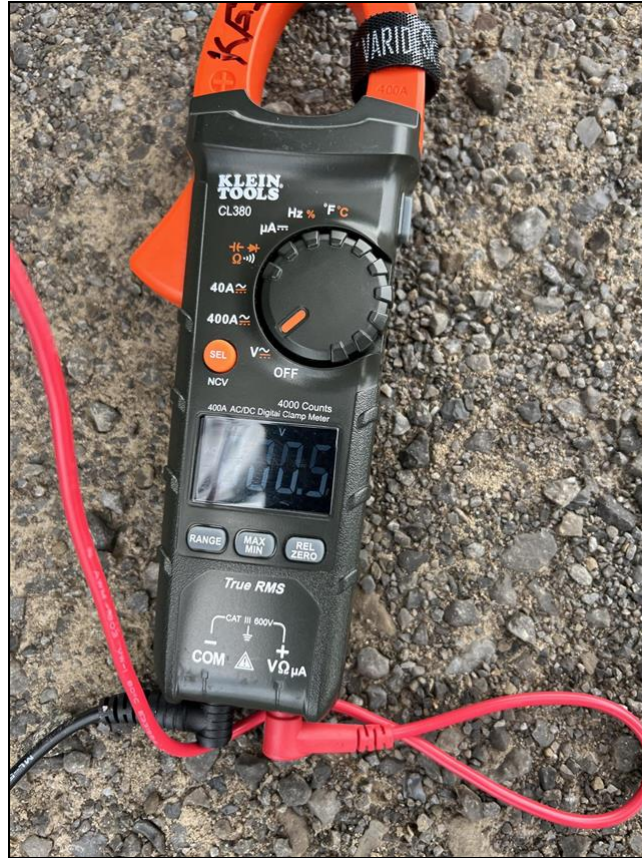
Volts recorded on jack.

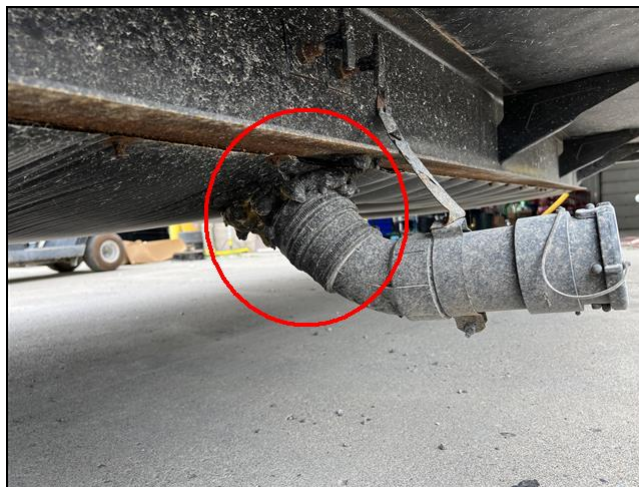
Waste water hose fitting were repaired by owner do to previous damage .

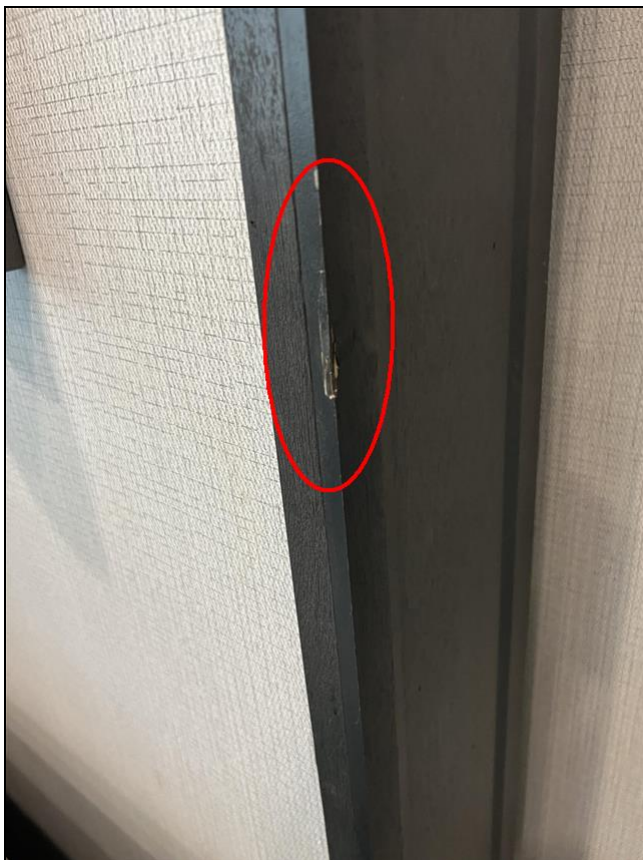
Alongside couch

There are areas throughout that have scratches and damage to trim work.

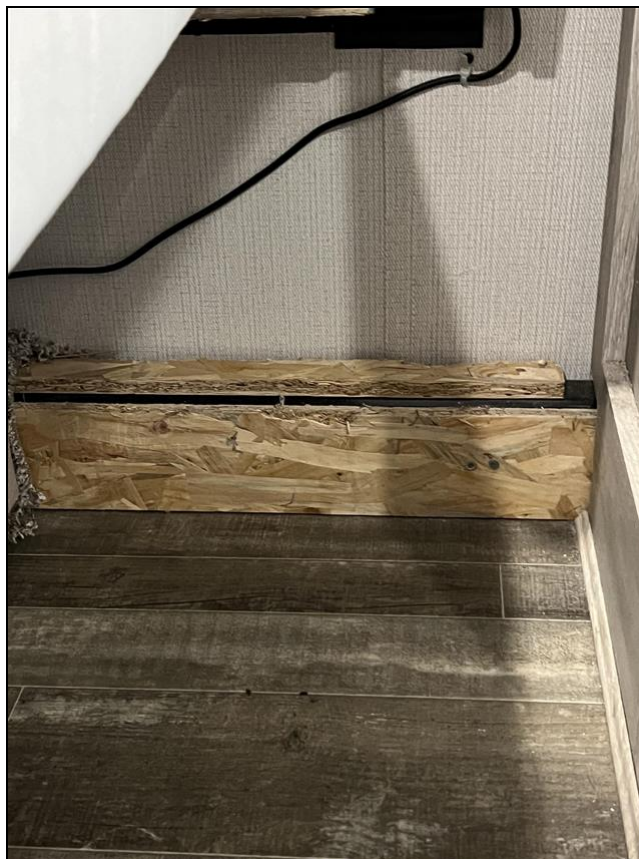
(2) Along right side of master bed there is wood showing and wires hanging.

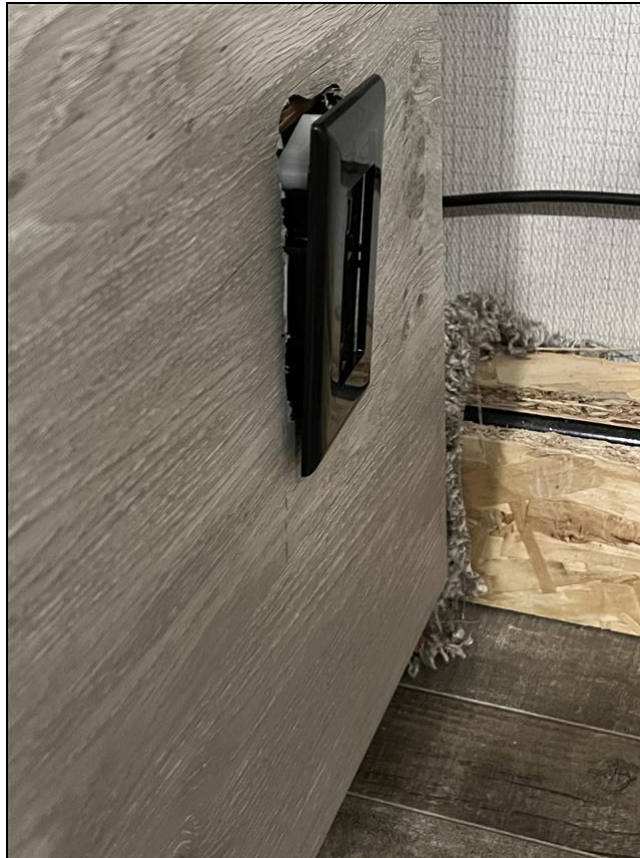
Electrical socket alongside right side of master bed is coming out of bed box.

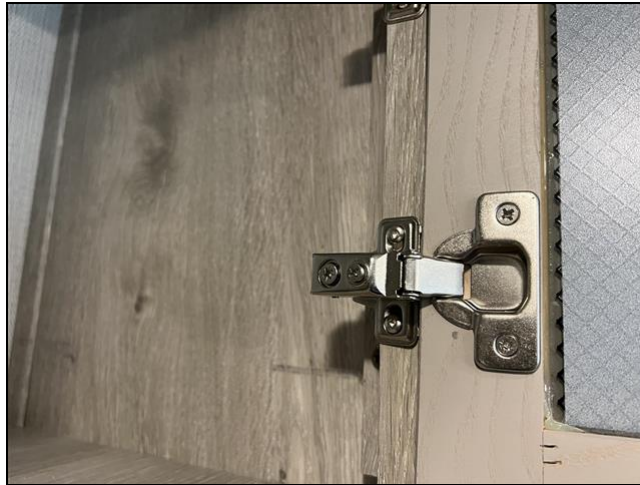
Right door hinge on upper cabinet above microwave is loose.

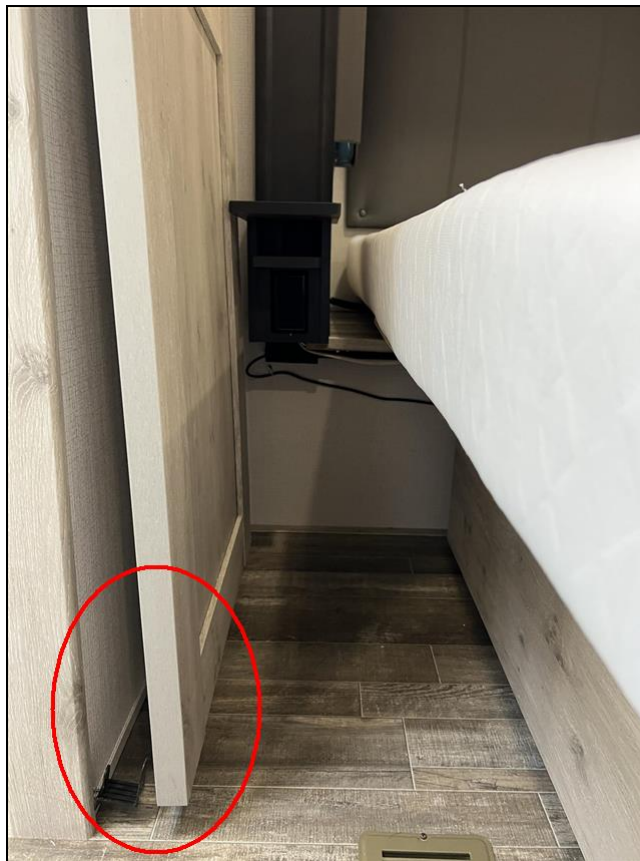
Master bedroom sliding door is not working properly. The door track support is broken.
