RV Inspection Report

2006 Winnebago Voyage 35A

VIN Number: VIN#5B4MP67GX63414371

TNT RV Inspections

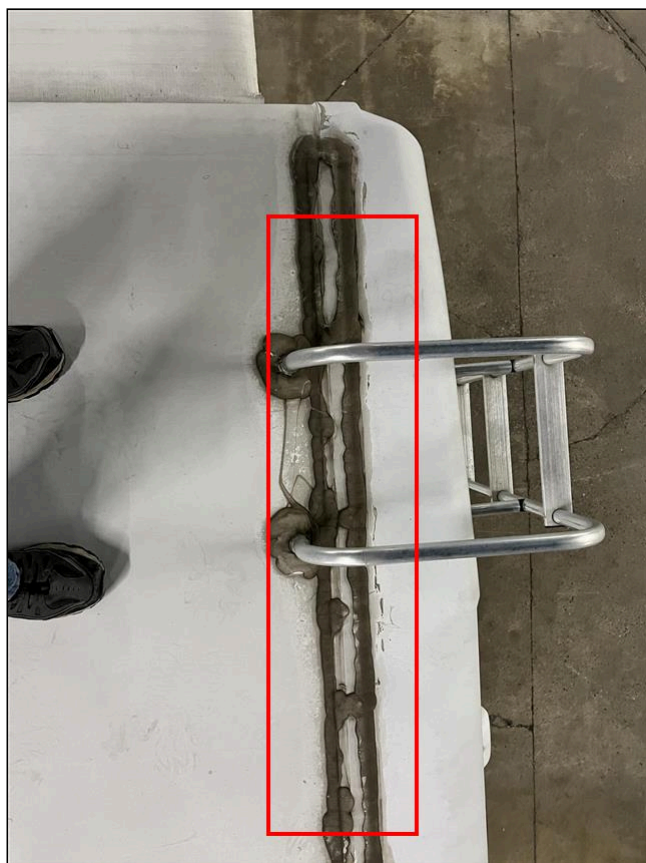
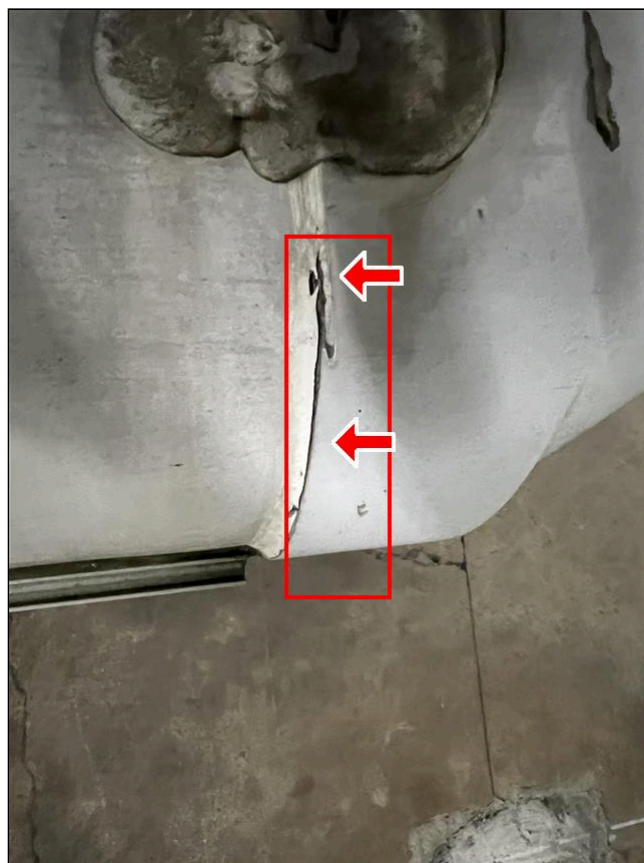
🔧 Sealant is becoming brittle and leaving a gap where the sealant runs under the ladder.

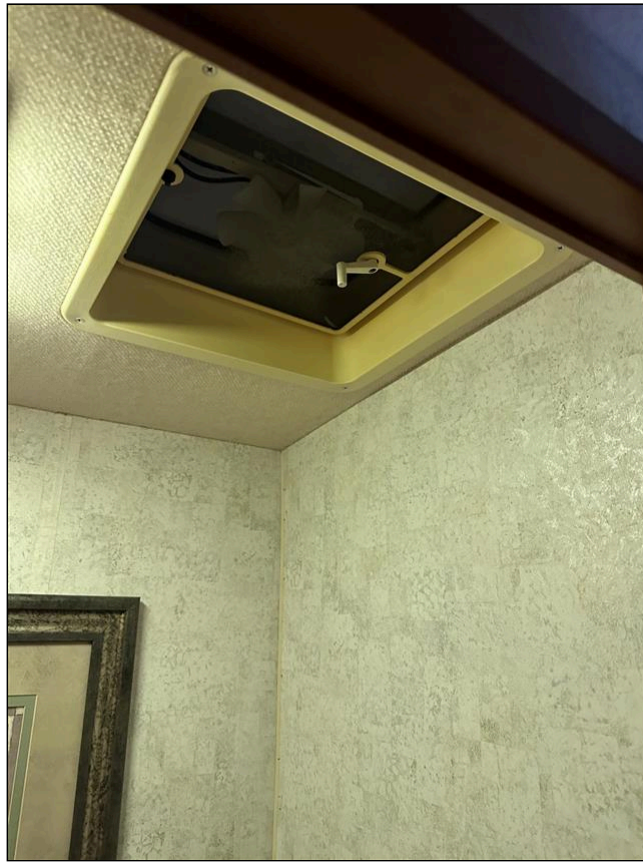
🔧 Bathroom vent will open, but will not turn on.

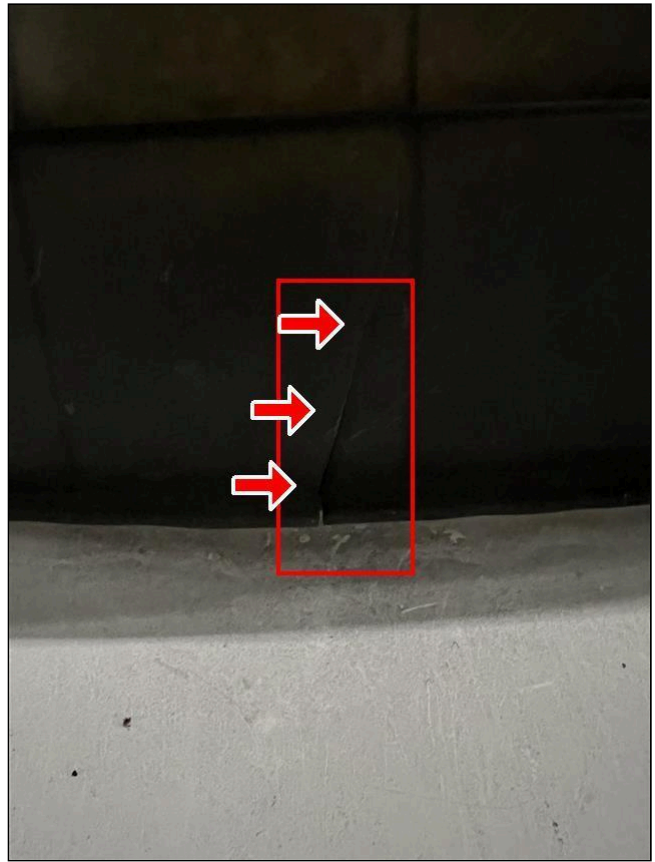
🔧 Front vent cover had a crack that is about 6 inches in length.

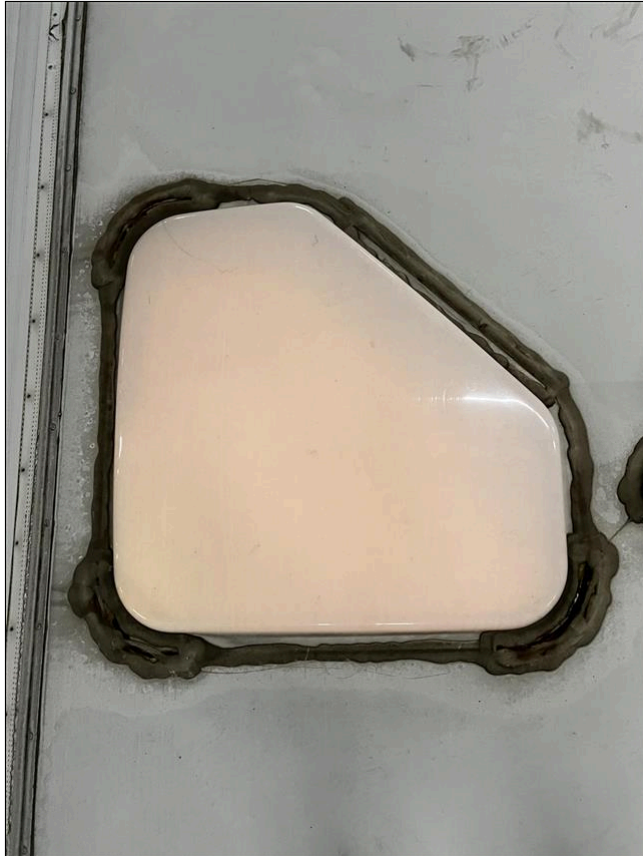
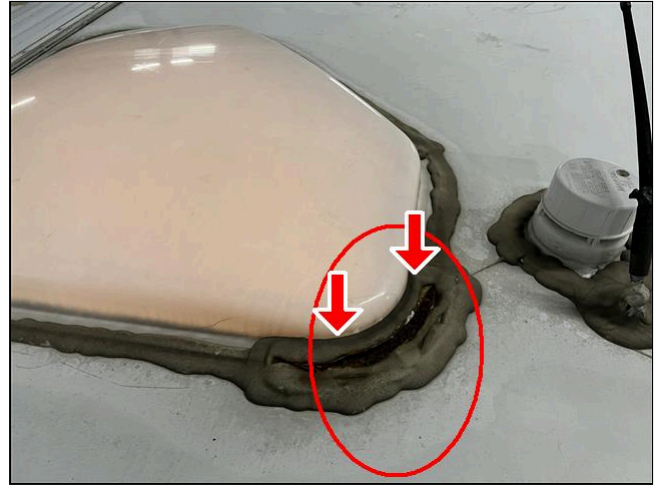
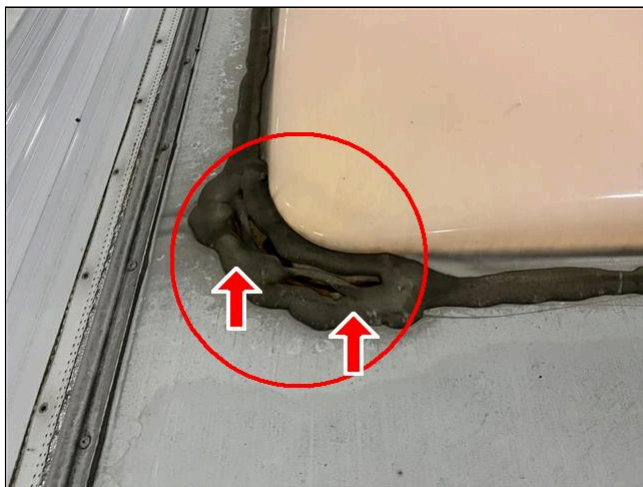
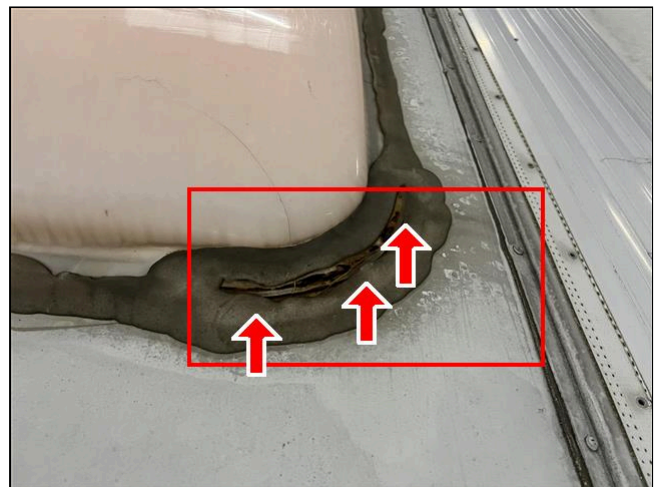
\$ Sealant on three of the 5 corners of the skylight are showing signs of deterioration and there is the possibility of water intrusion.

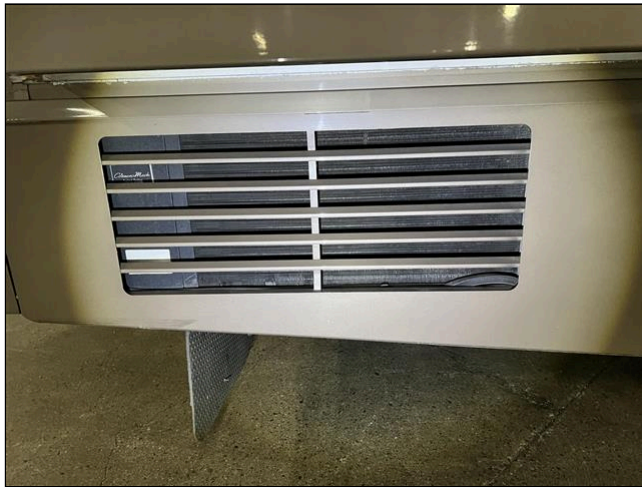
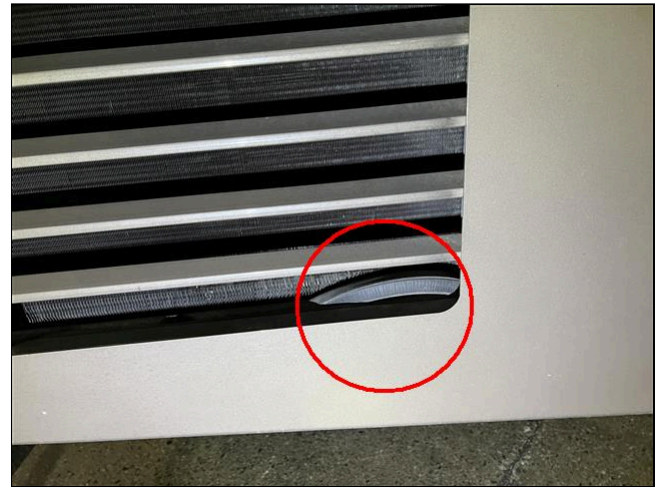
Side AC vent

The seal on the lower right corner of the side AC vent is starting to come undone.

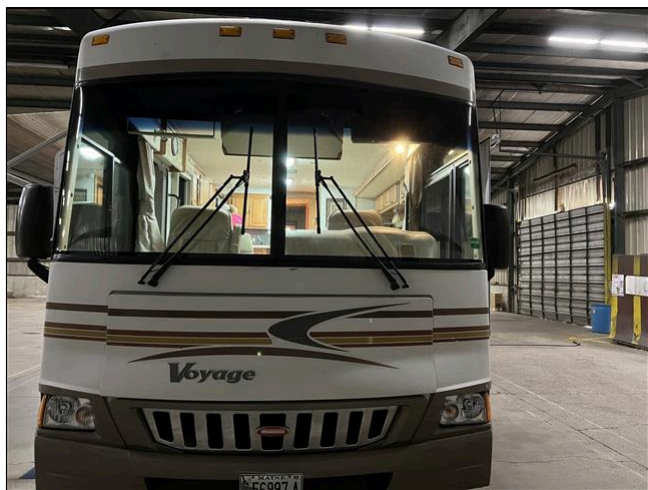
Upper streetside corner

The upper street side corner and where the center seal meets the roof there are areas of sealant missing which could lead to the possibility of water getting in.

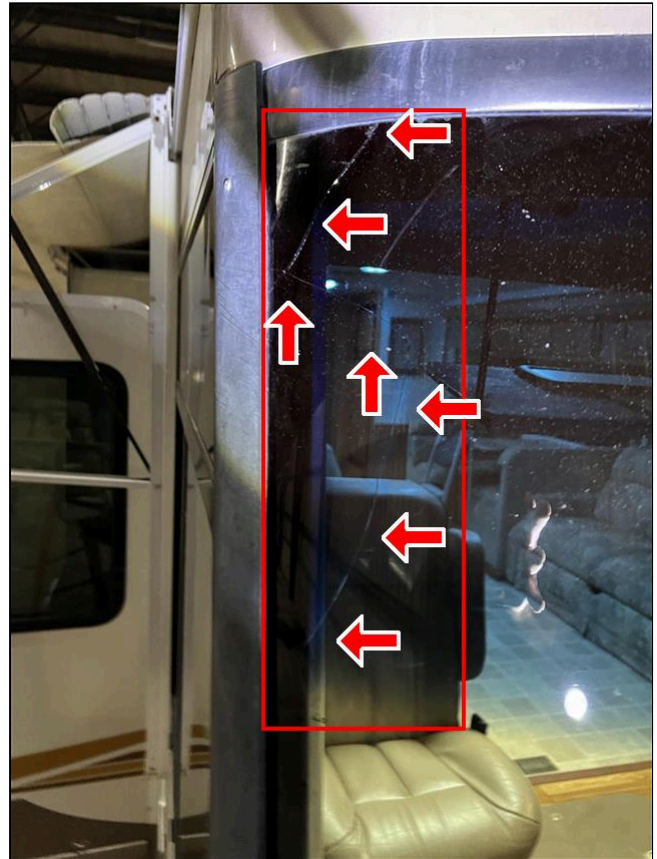
Crack

There is a large crack on the upper curbside of the window the zig zags for about 18 to 20 inches.

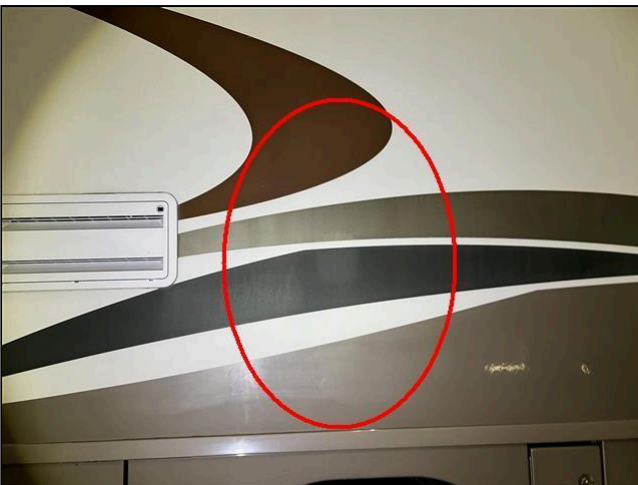
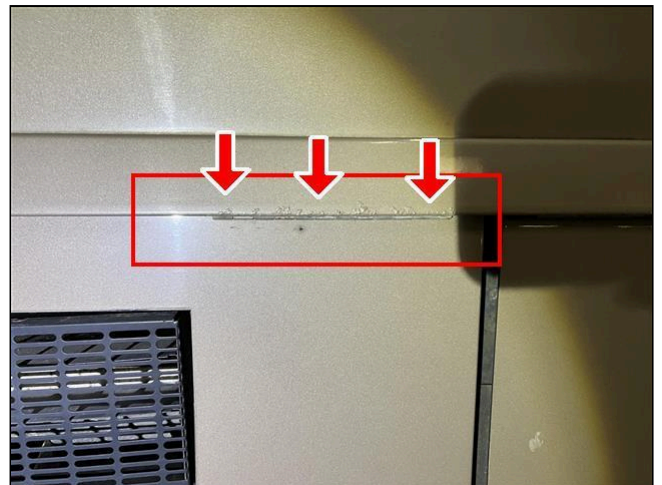
🔧 The sidewall is faded and there is an area just about furnace vent that is showing signs of rust forming under paint.

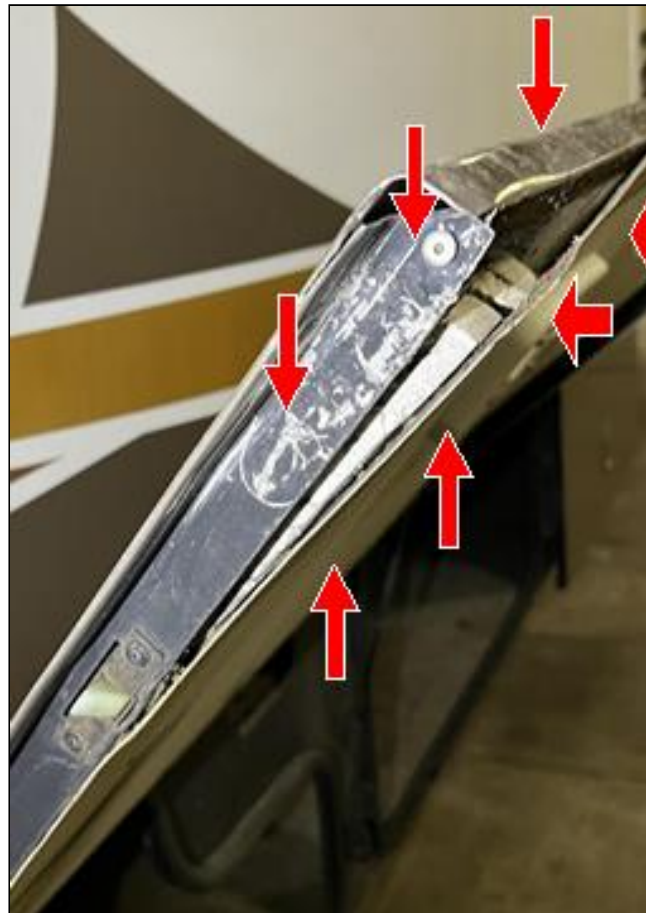
Front cargo door

(1) Some of the seals around 2 of the doors are coming undone. The front most door is beginning to separate and leaving a large hole between outer wall and inside wall.

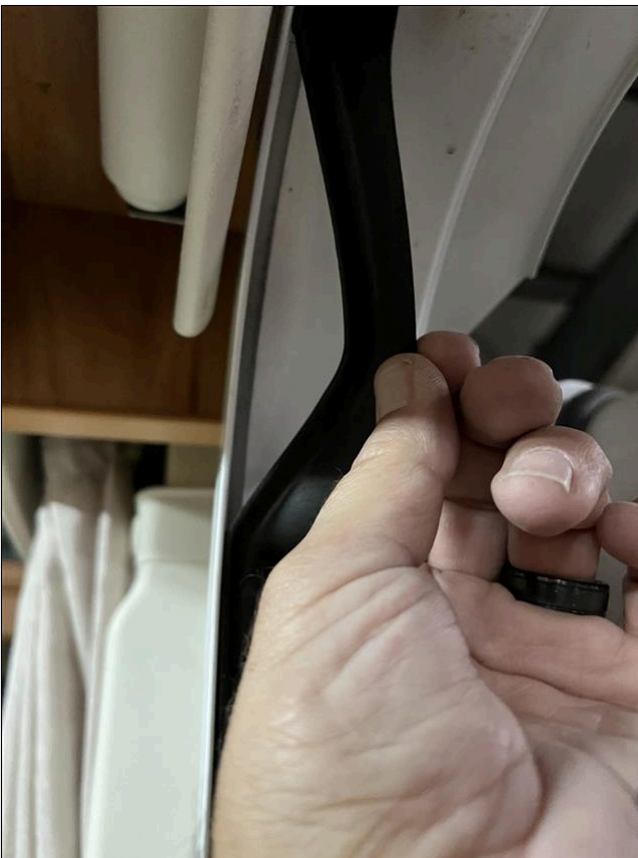
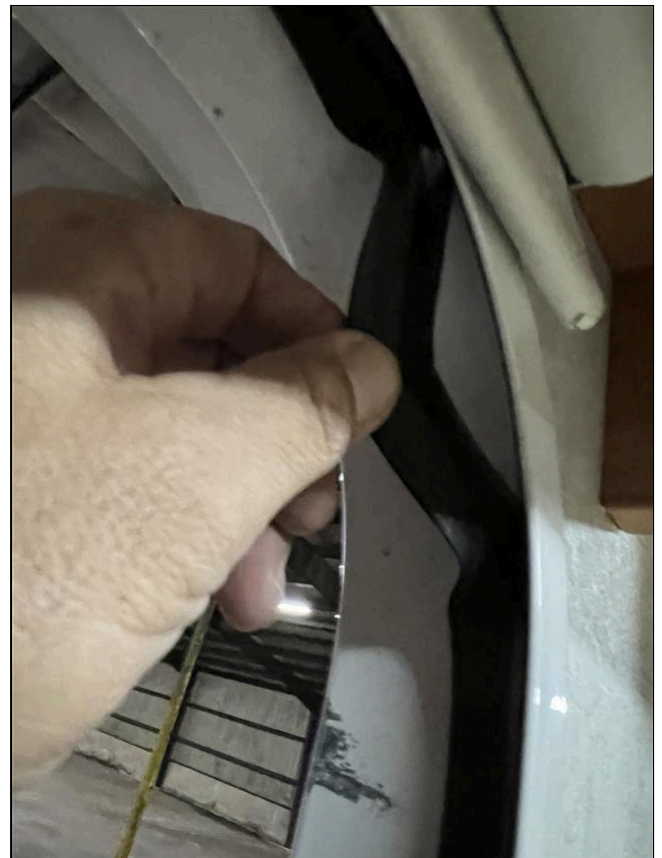
(2) Upper left and right seal of the door frame is coming detached.

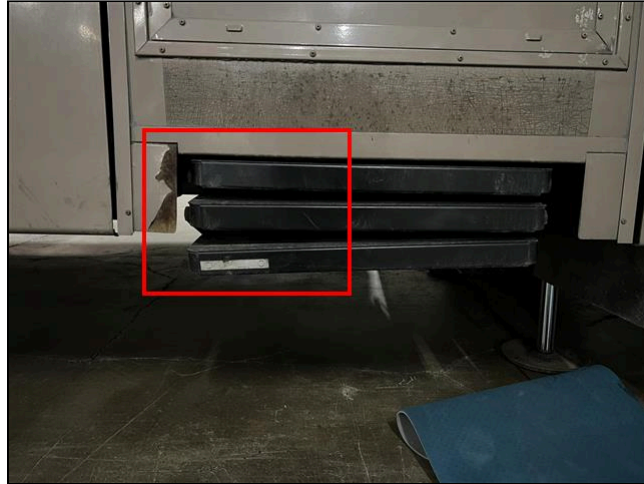
- (3) When the steps are retracted the left side is hanging lower than the right side. There is also rust forming on the left side.

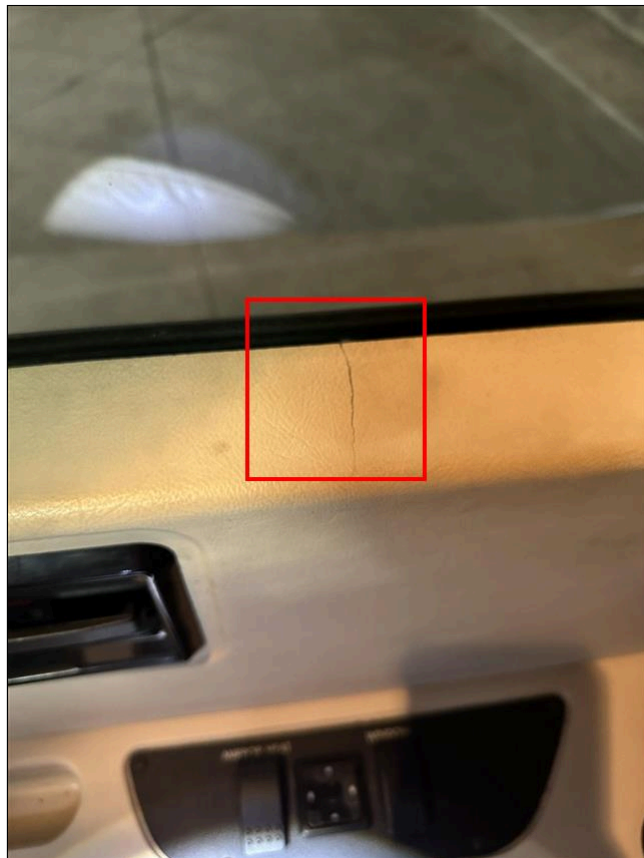
🔍 (2) Crack on pad that runs along window.

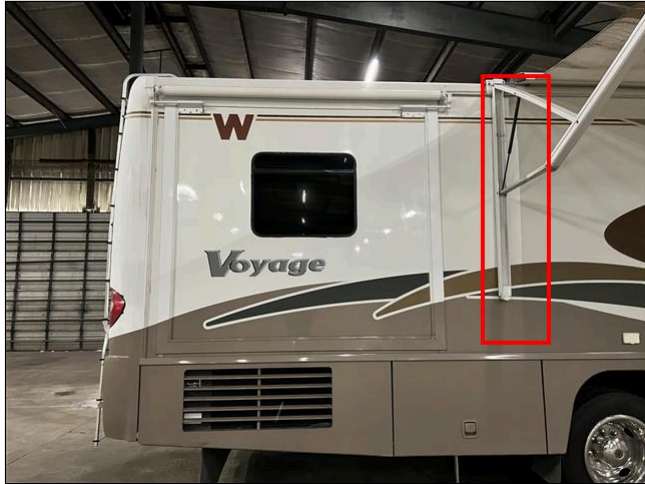
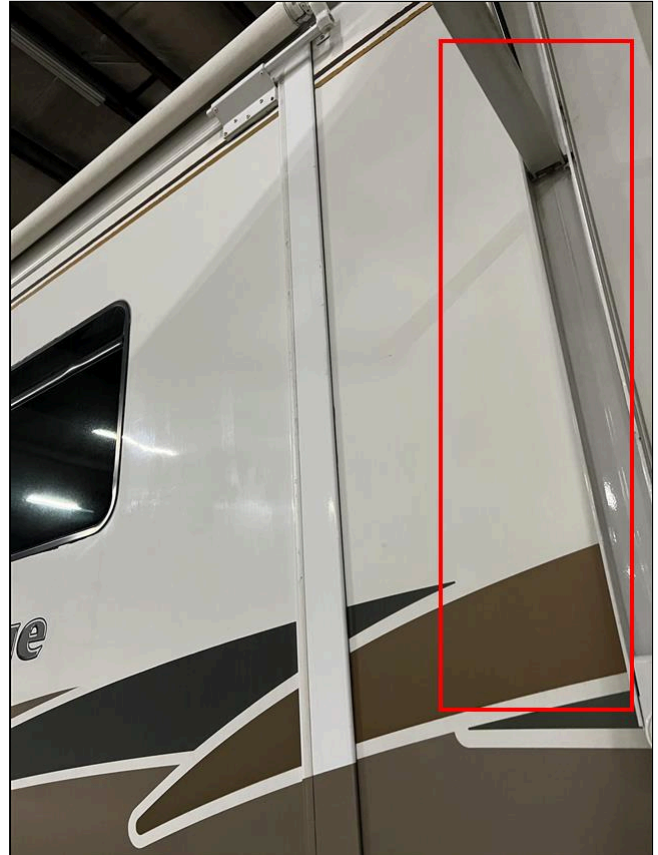
\$ The left and right arms do not extend on their own. Both arms need to be pulled away from support to get them started, then they will extended on its own.

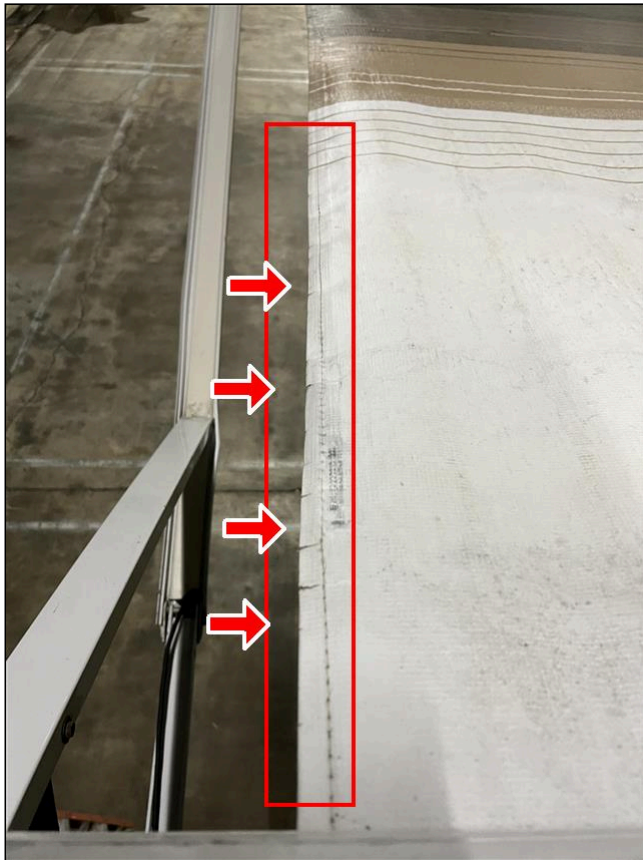
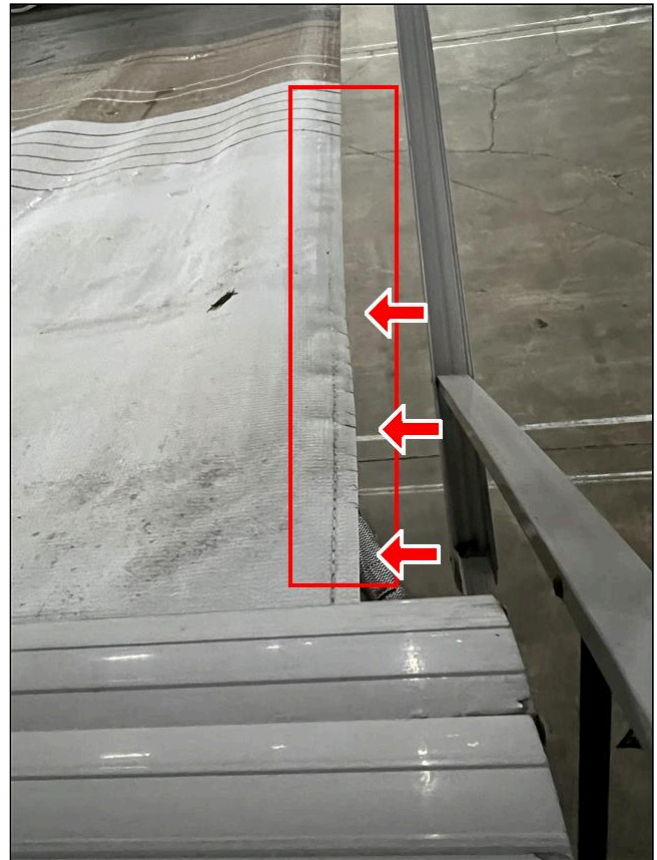
(1) The left and right side of the awning fabric edge is beginning to tear and crack.

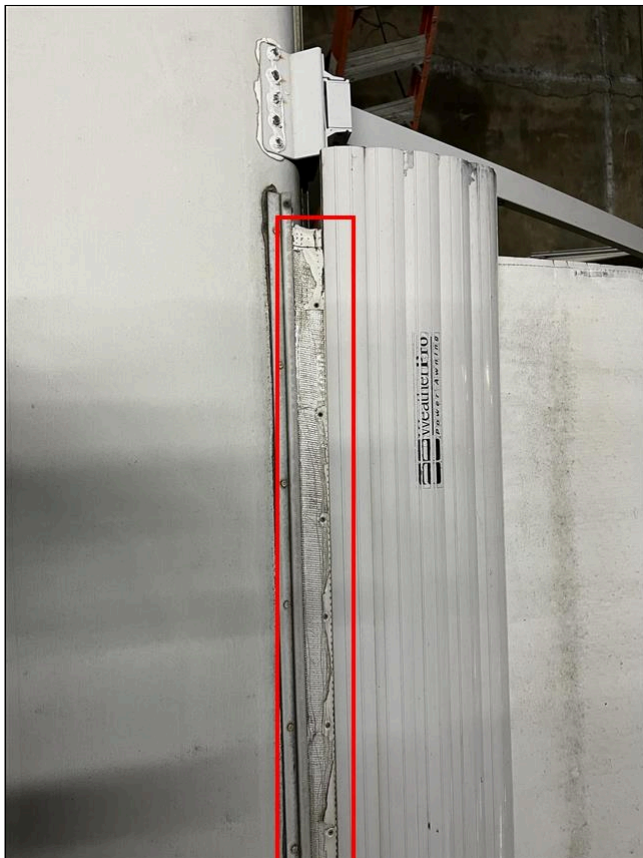
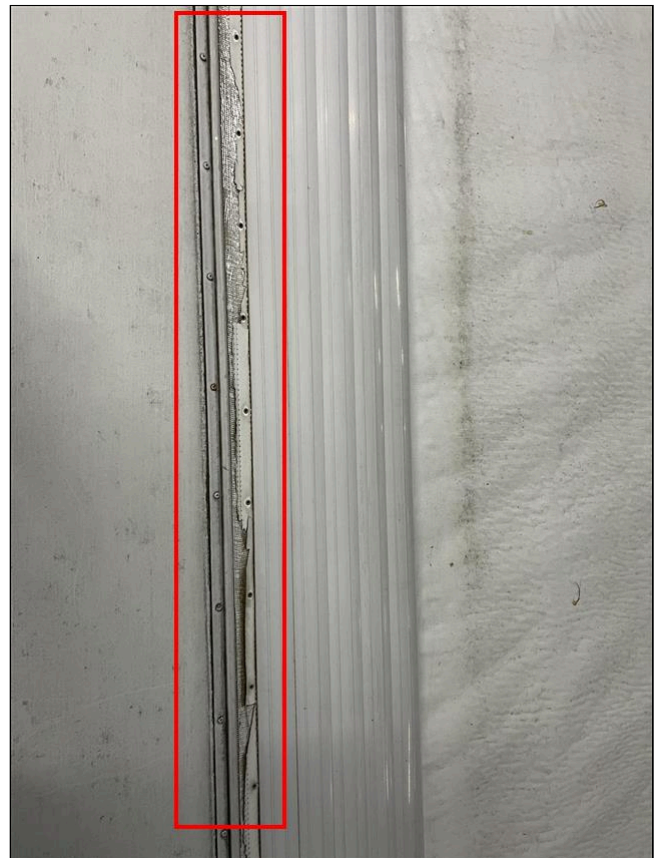
(2) Fabric that holds the awning cover to the roof in deteriorating and beginning to tear.

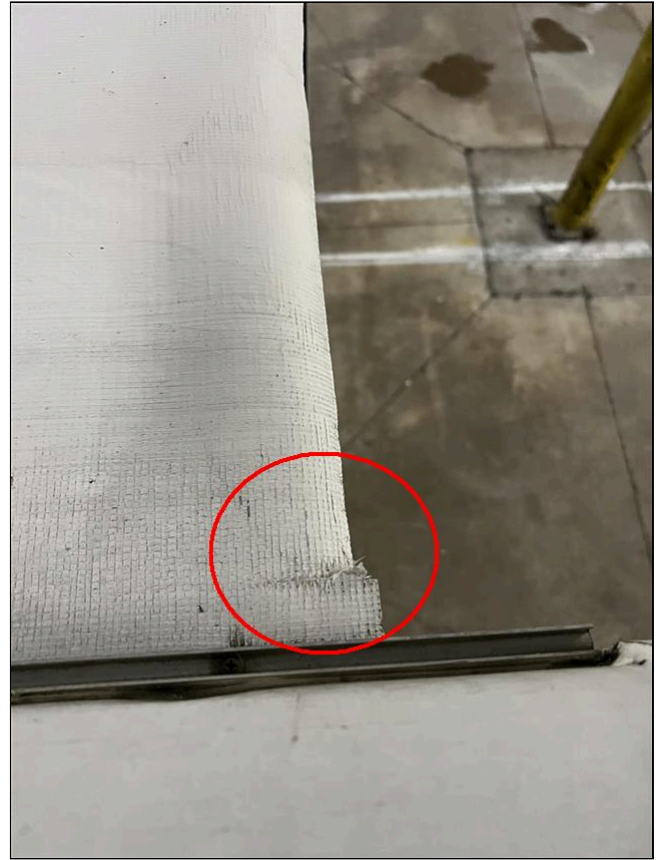
Awning topper has tears forming on the left and right sides where it meets the roof.

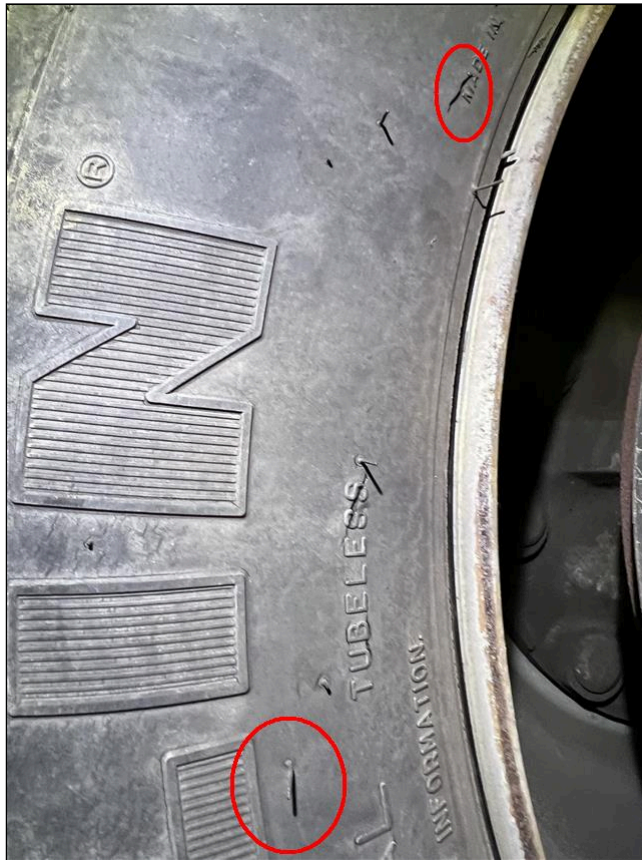
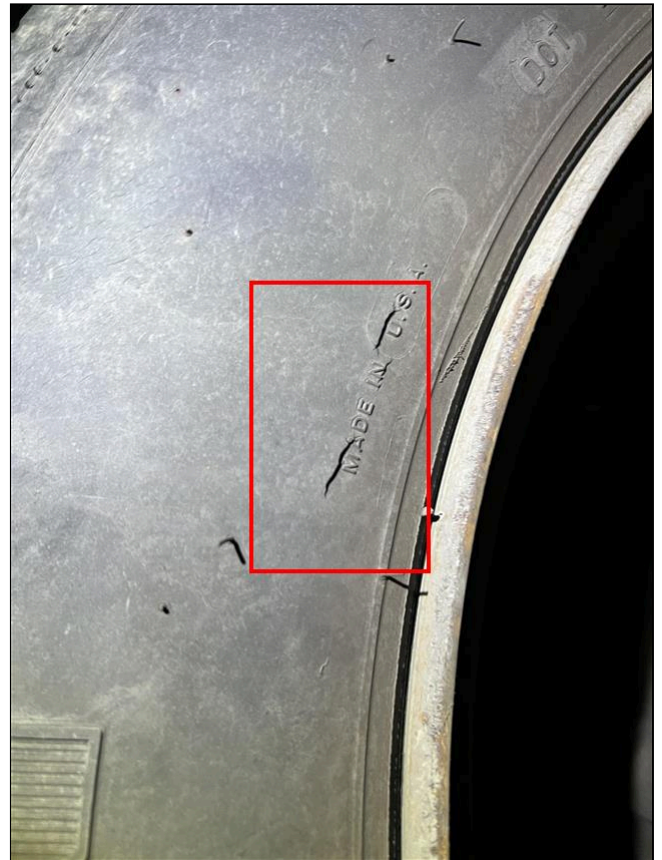
The curbside inside drive axel tire has signs of weather checking.

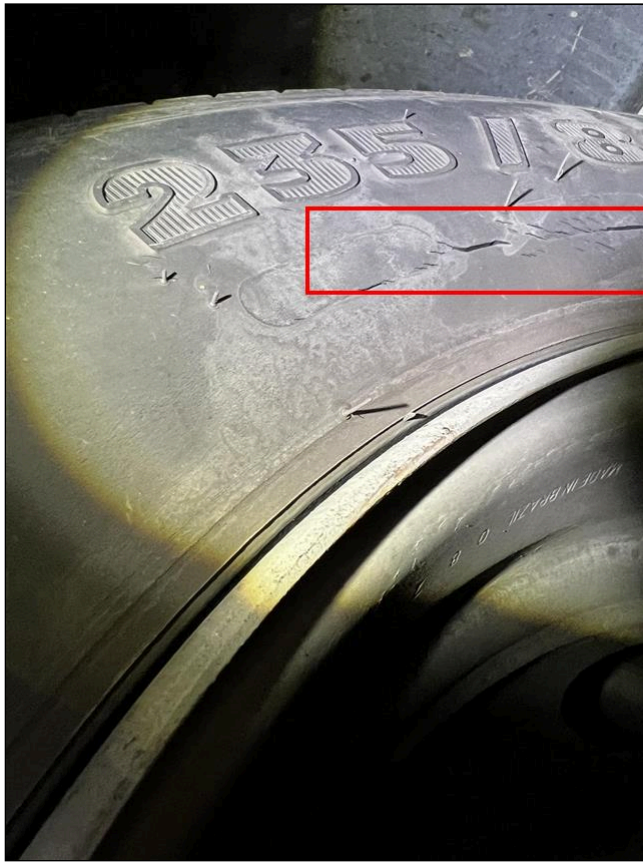
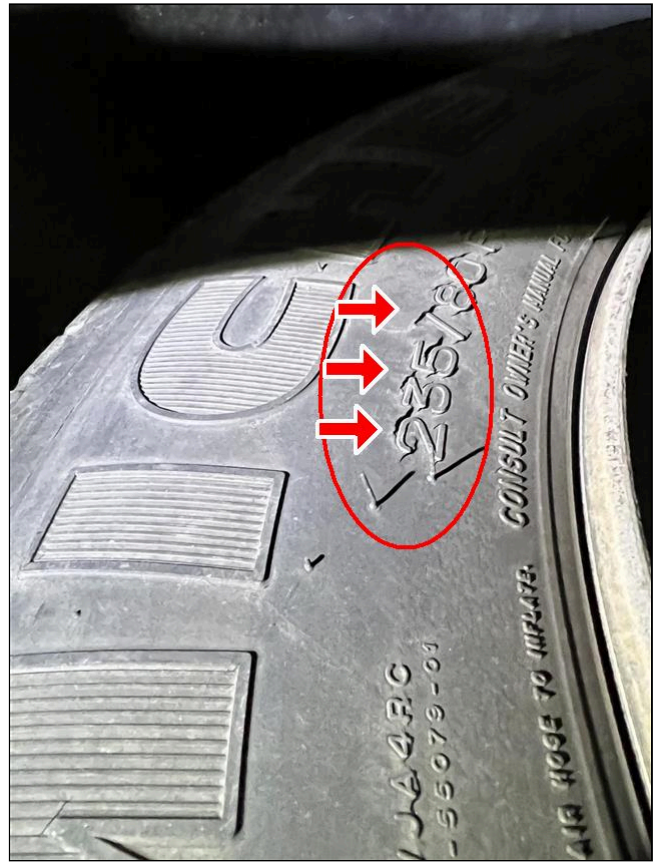
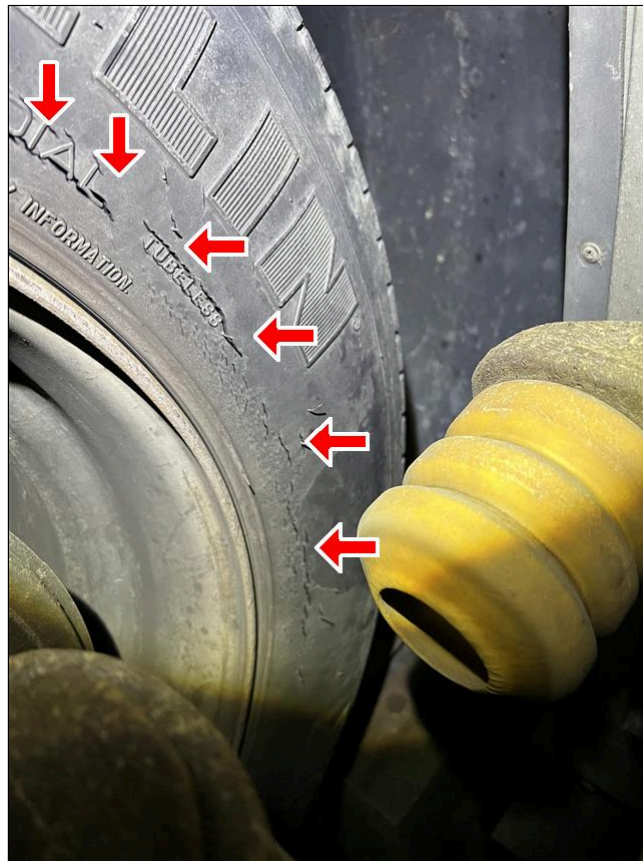
The streetside inside drive axel tire has signs of weather checking.

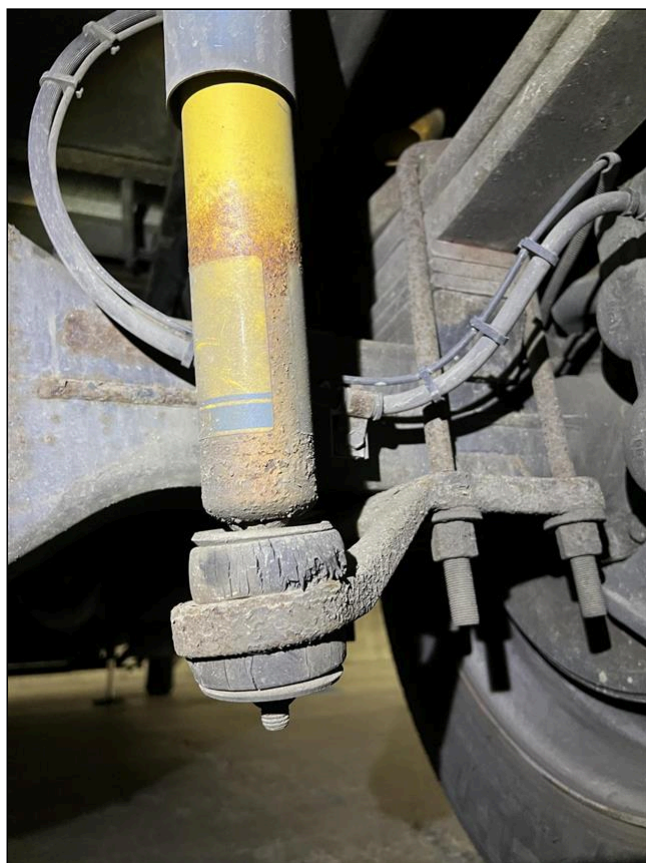
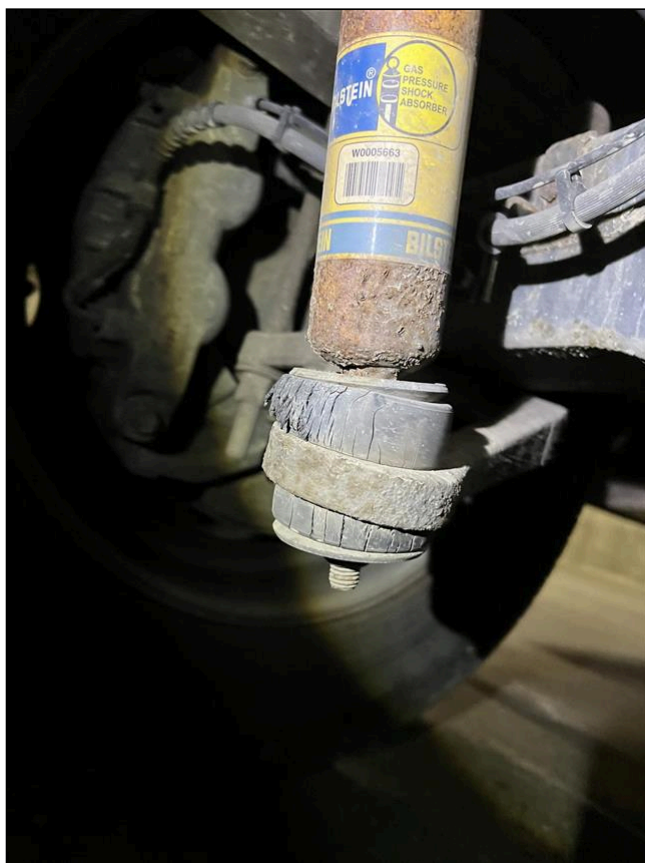
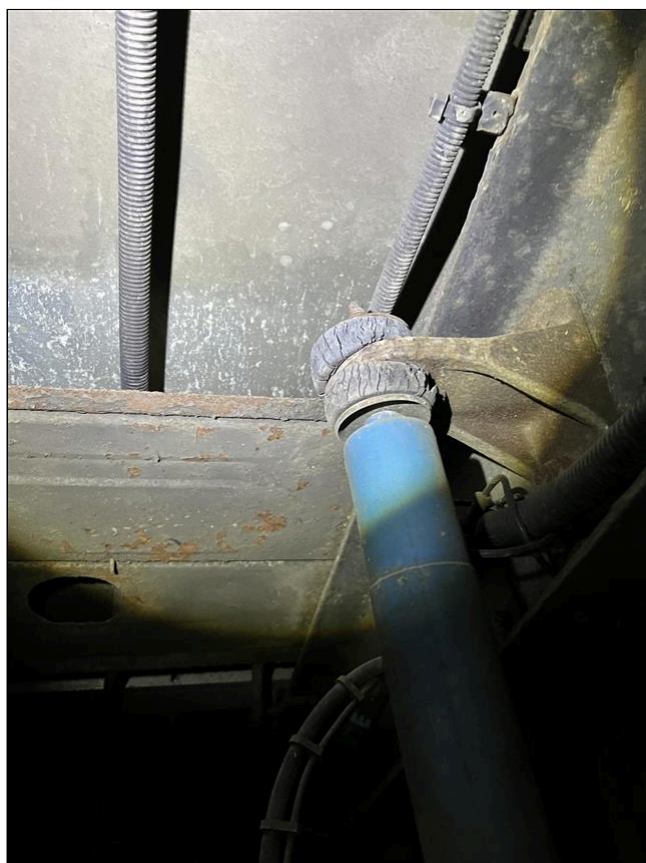
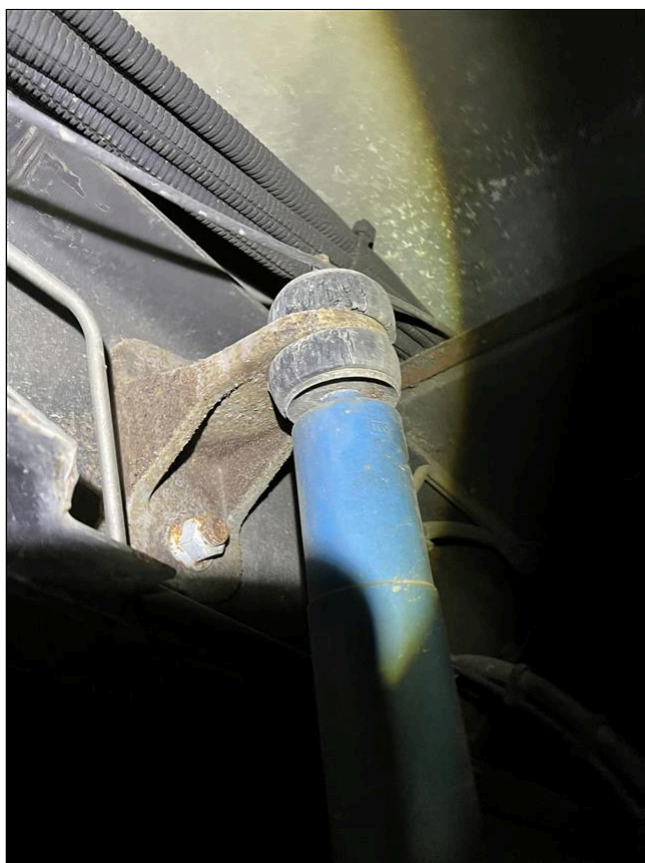
🔧 All shock rubbers are showing signs of deterioration.

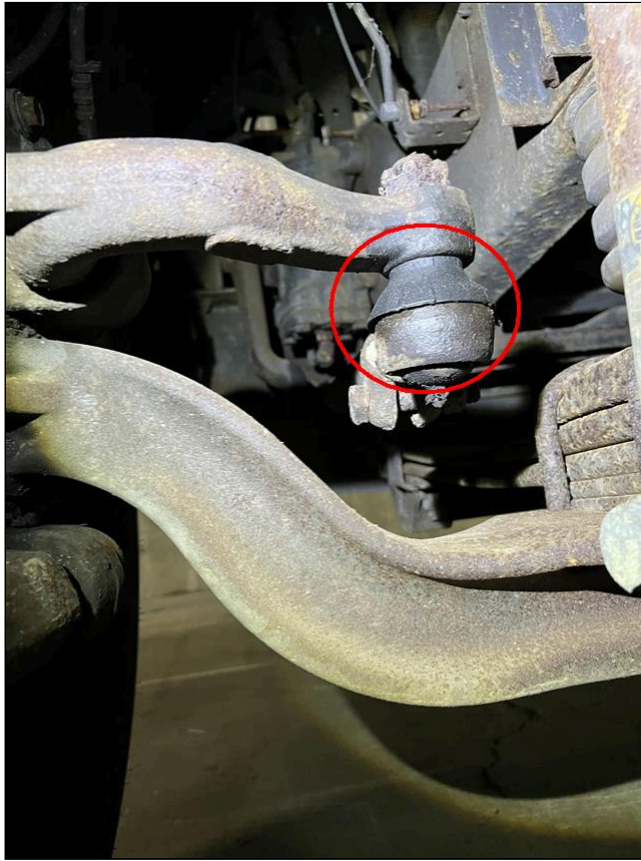
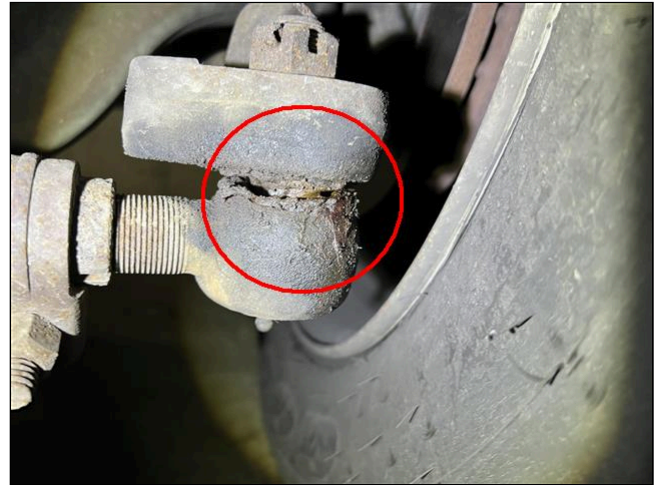
🔧 Rubber covers on steering components are showing signs of deterioration.

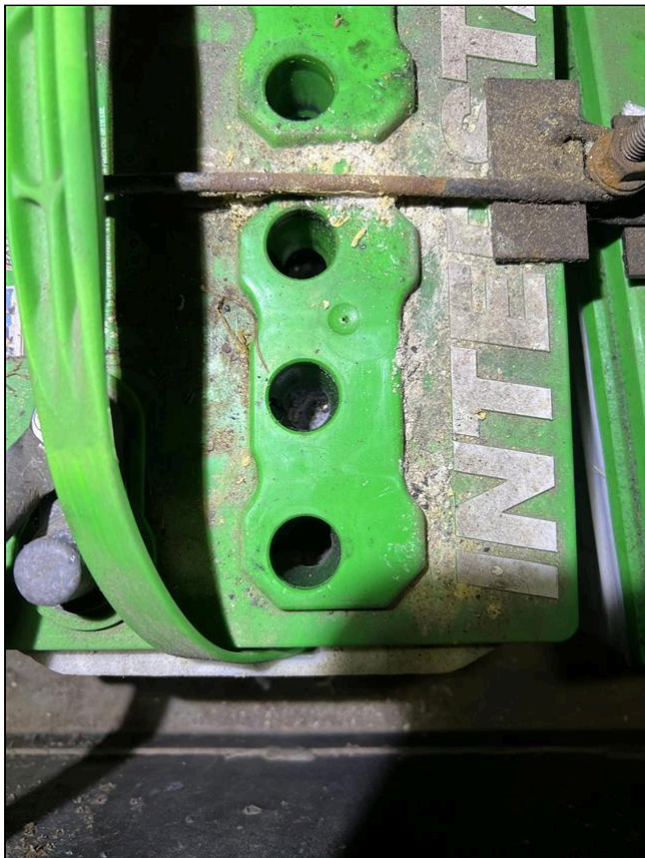
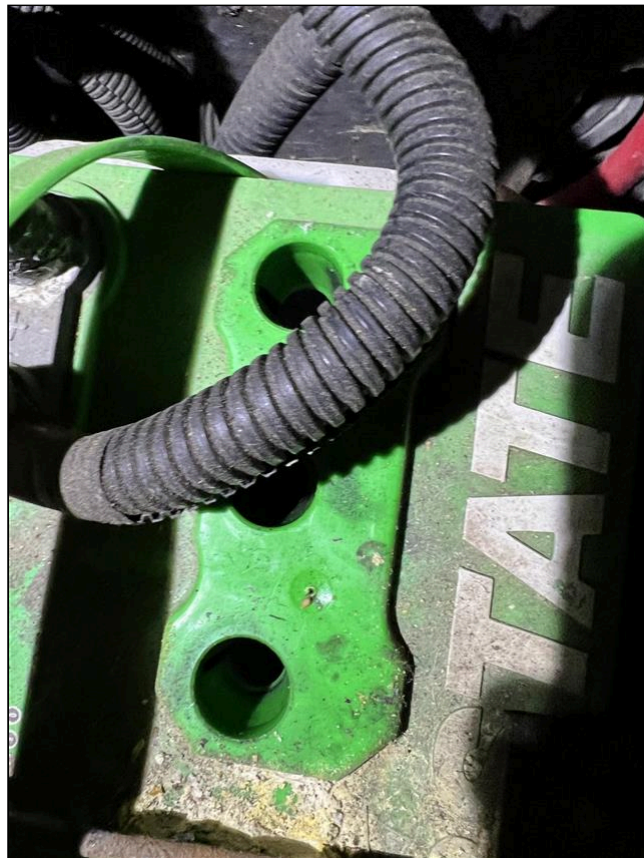
Two of the three batteries the water level was either unable to be seen or extremely low.

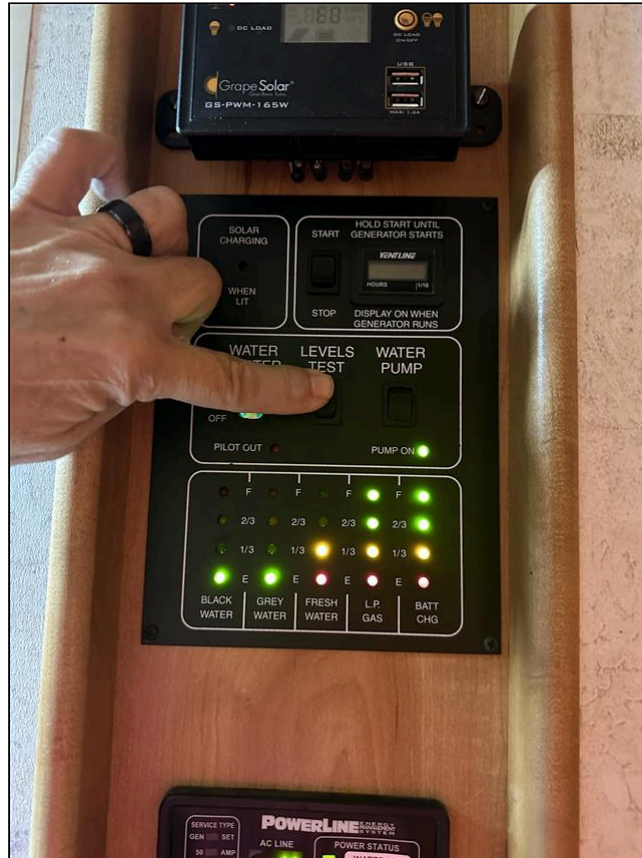
The LP panel monitor shows full, but the tank gauge shows 1/4 tank. The owner stated that the panel sensor it is not function properly.

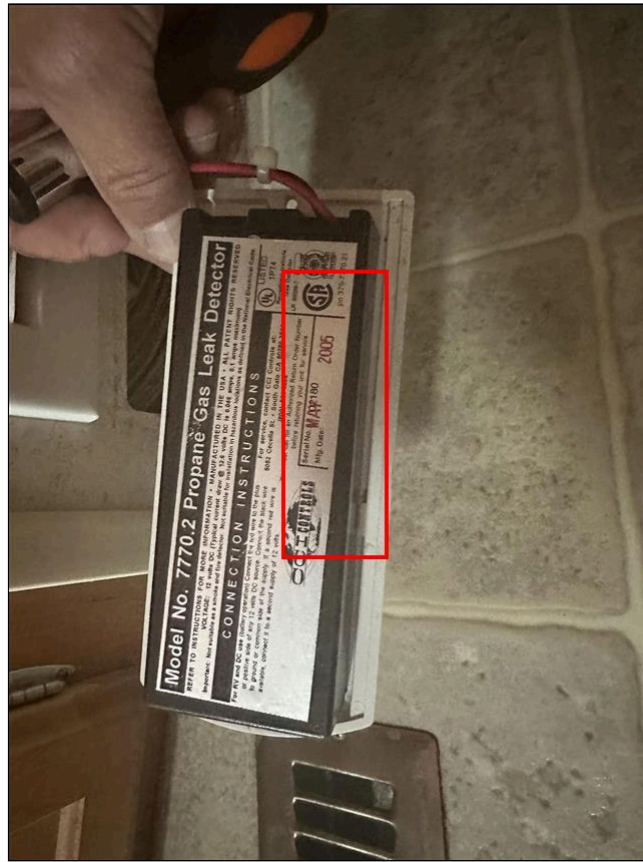
\$ The LP detector date is May of 2005.

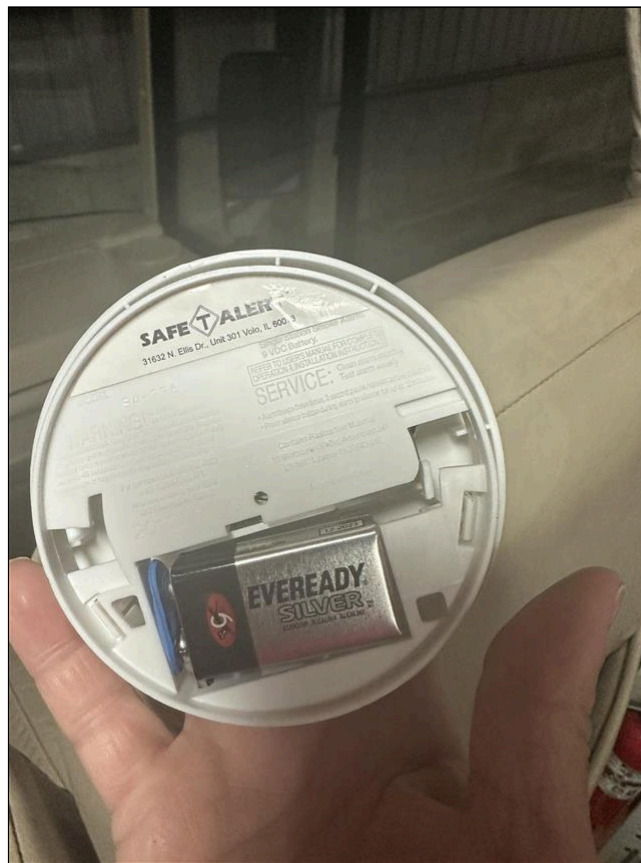
Carbon Monoxide Detector has expired in 2012.

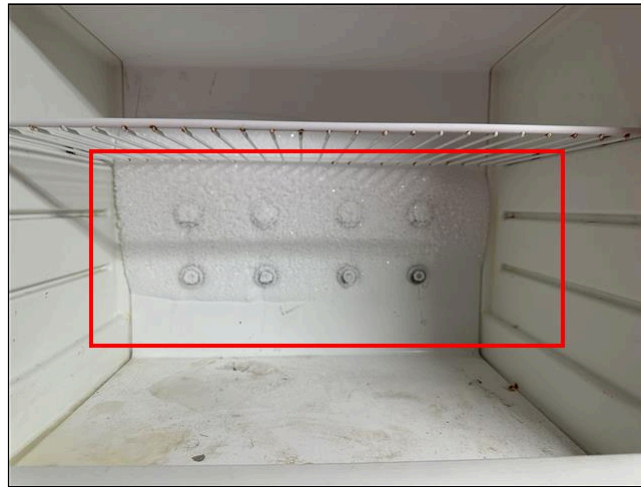
Frost

Freezer had frost build up on back wall.

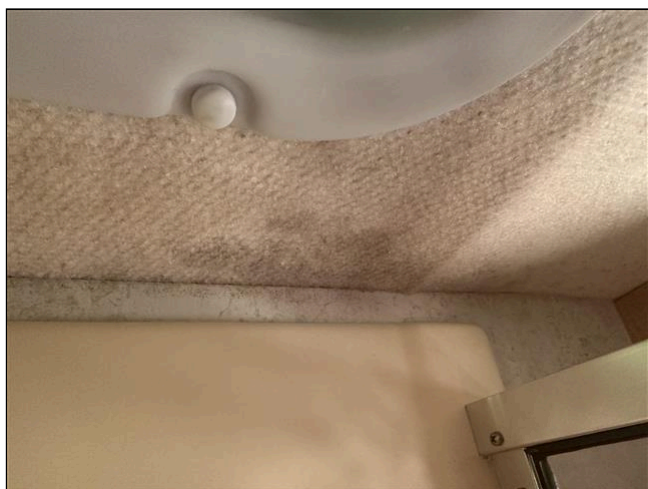
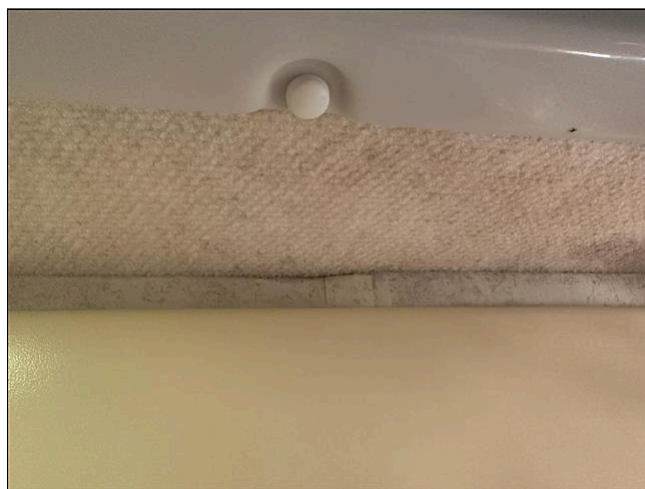
Stains on ceiling above shower stall.

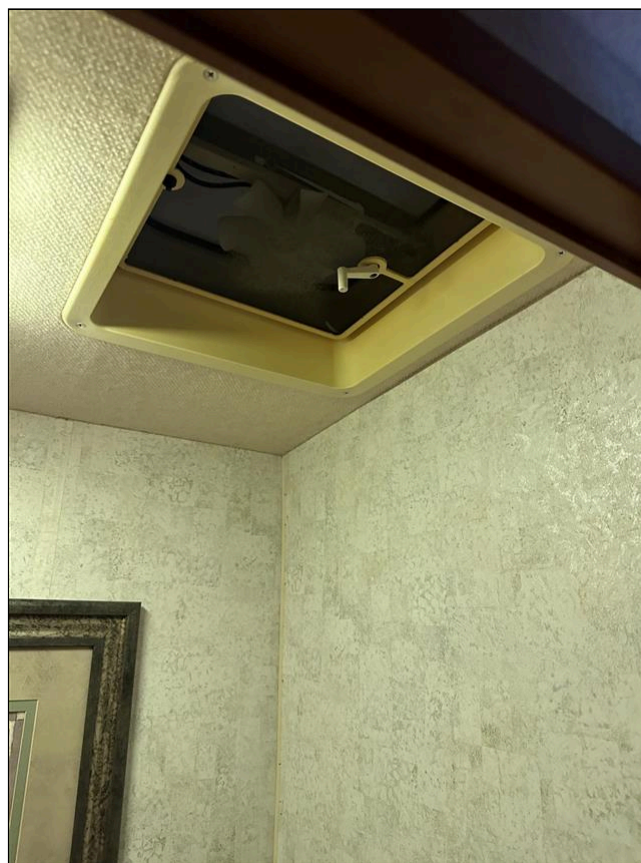
Bathroom

Vent in living room works. The vent fan in the bathroom does not come on.
