RV Inspection Report

2006 Winnebago Voyage 35A

VIN Number: VIN#5B4MP67GX63414371

TNT RV Inspections

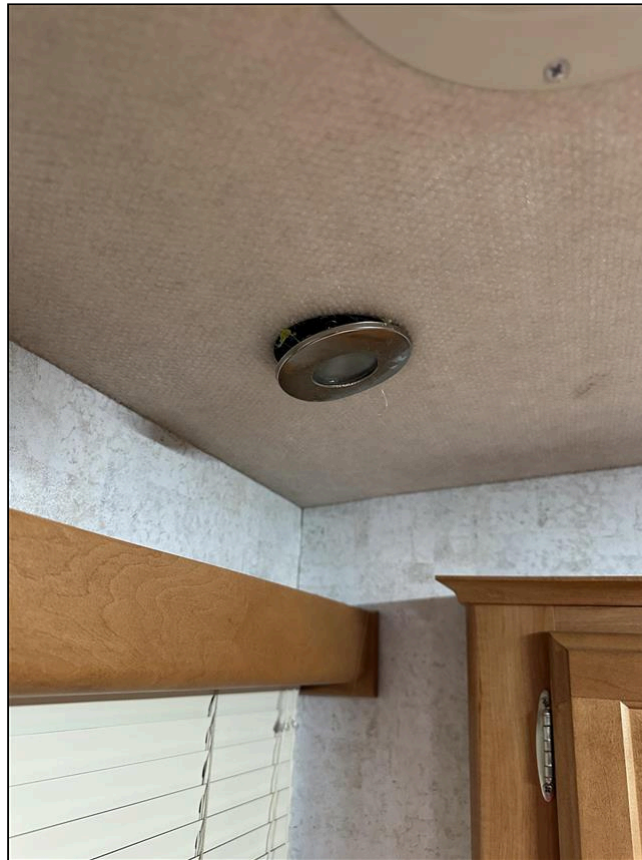
Ceiling light over the sink is not properly installed. The light still works.

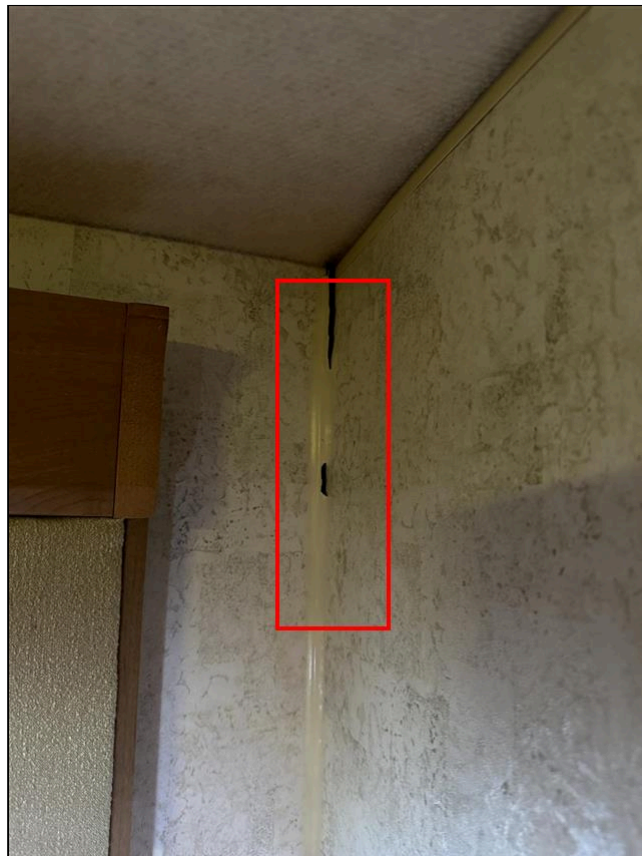
- (2) Separation of seem in bedroom in the upper left rear side of bed.

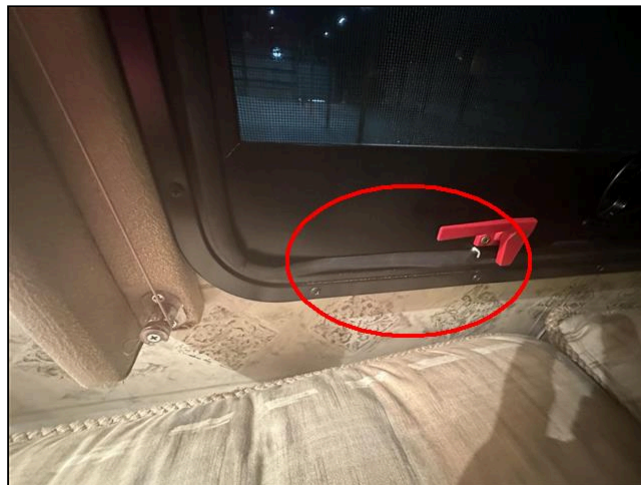
(1) Seal on lower left bedroom emergency window is coming apart, allowing the window to close hard.

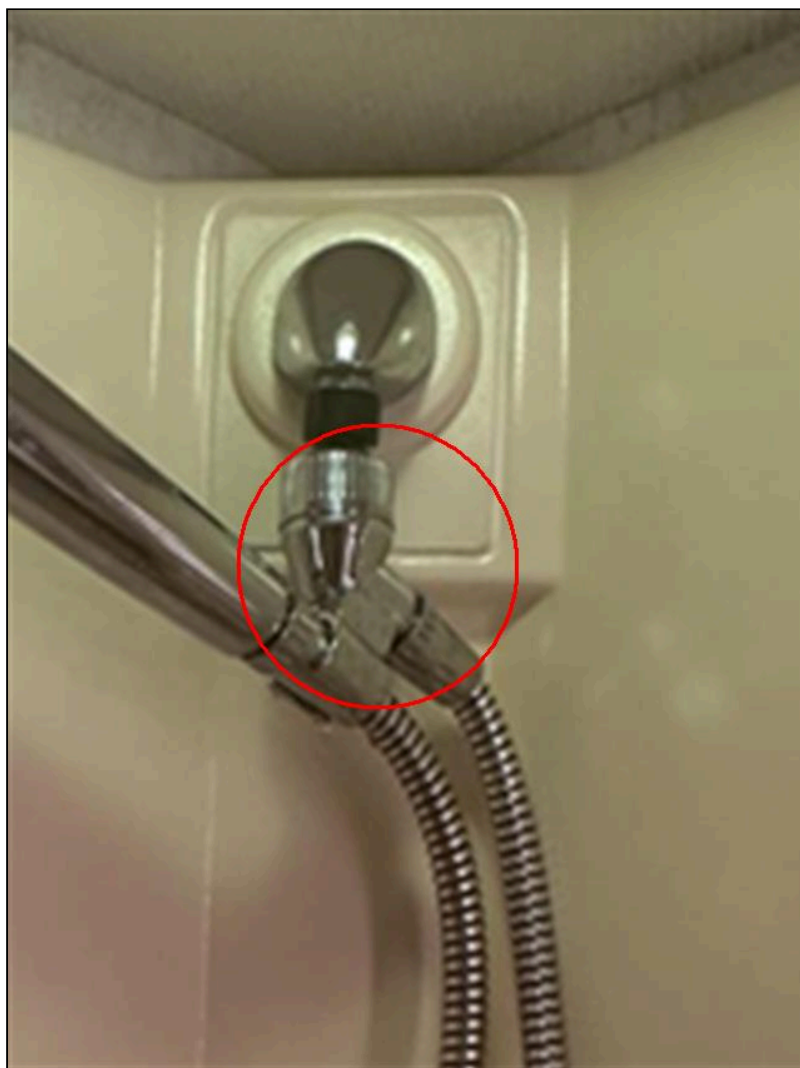
Water leaking at shower hose joint.
