# RV Inspection Report

2022 Forest River Avalanche

**Inspection Date / RV Model:  
2022 Keystone Avalanche 390DS**

TNT RV Inspections

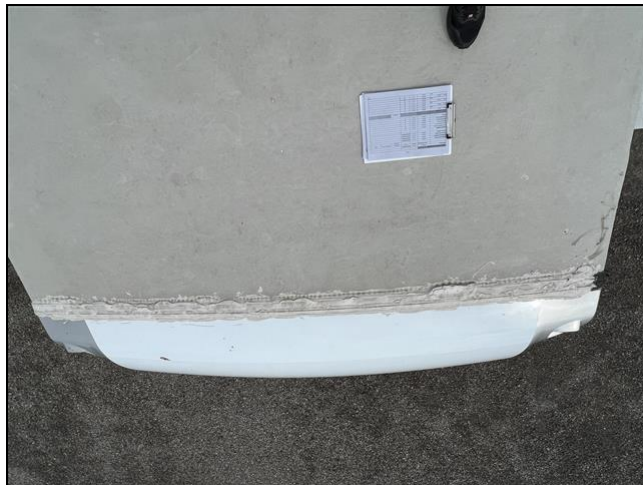
(2) Overall view of front cap joints and seal.

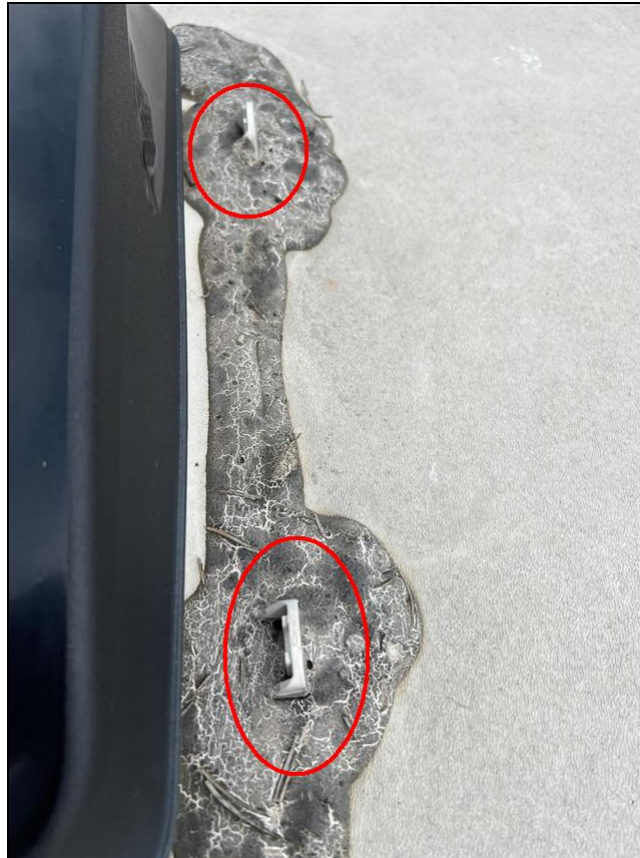
(1) The clips on the vent looked as though they are not attached and sealant was placed over them.

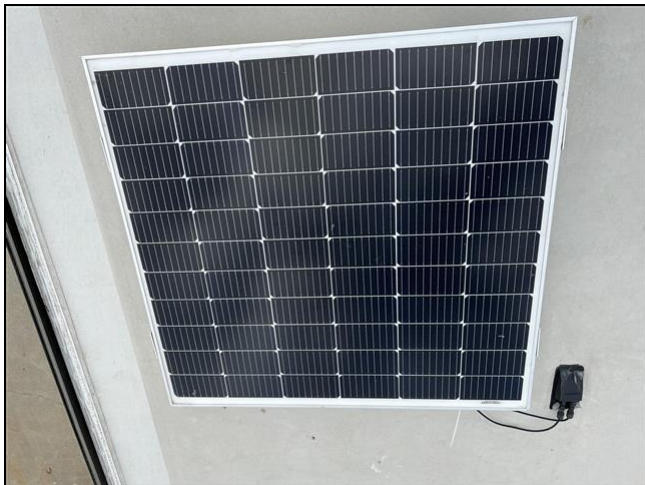
Video show the roof plywood alongside the front edge of the solar panel is lifting.

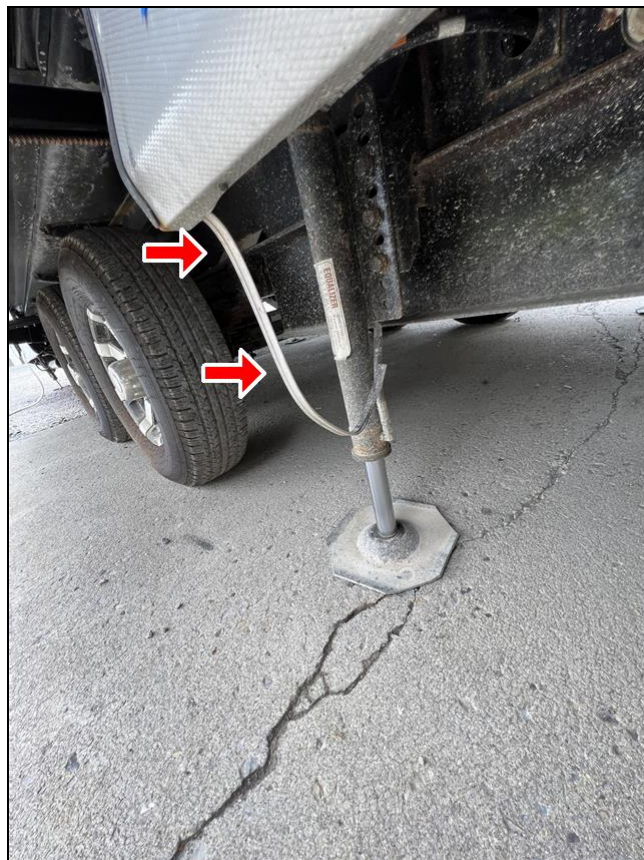
(2) Strap between the 2 slide boxes that holds the sidewall to the frame has become detached.

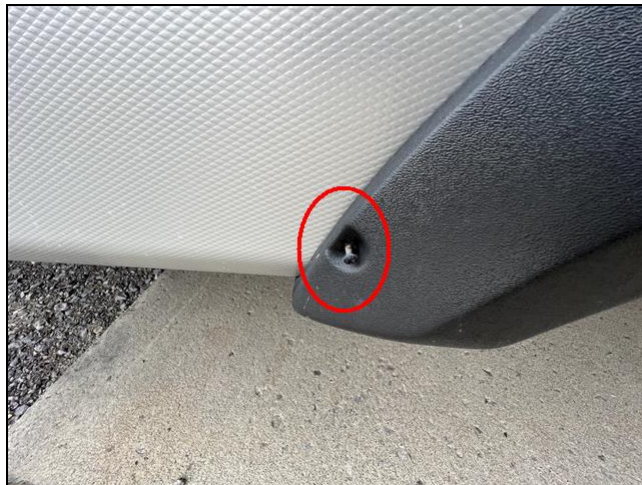
[\(1\) Screw coming out of fender.](#)

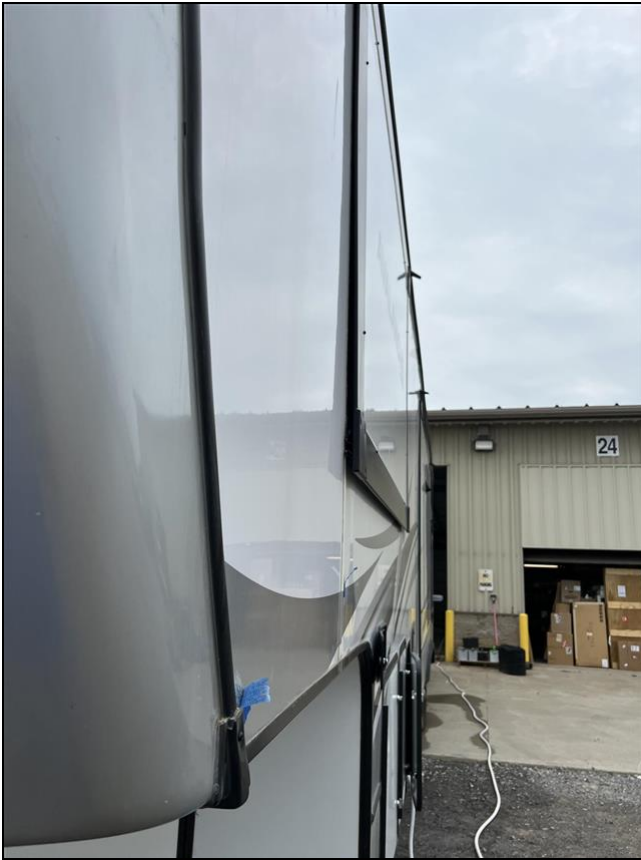
The lower front and rear of the slide out are not touching side wall. It appears that the slide box is warped.

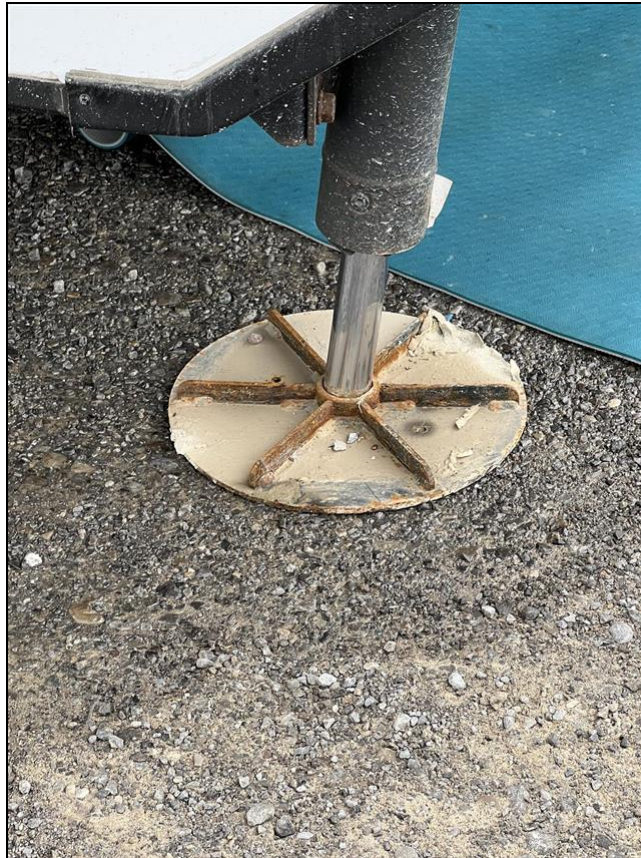
Streetside front landing gear bent.

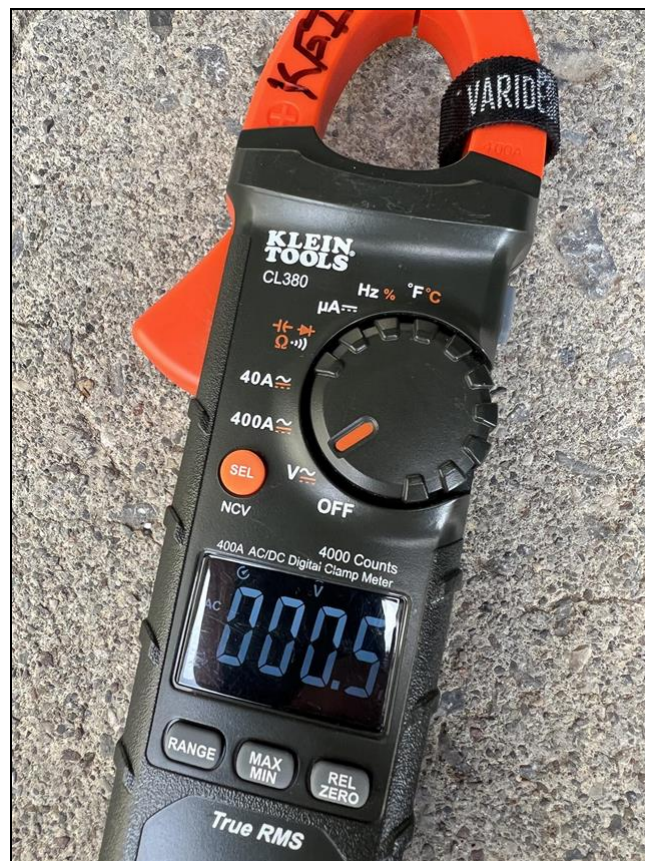
Volts recorded on frame

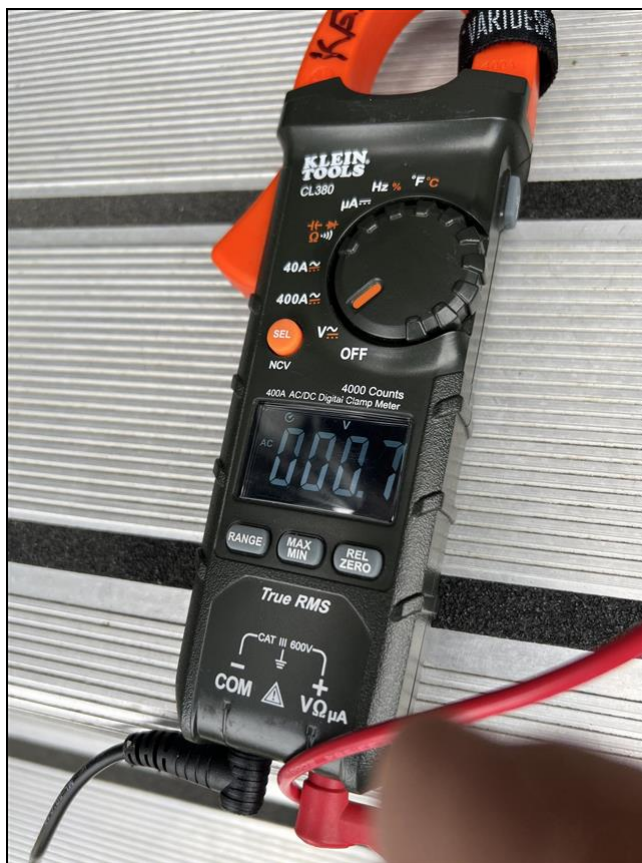
Volts recorded on door frame

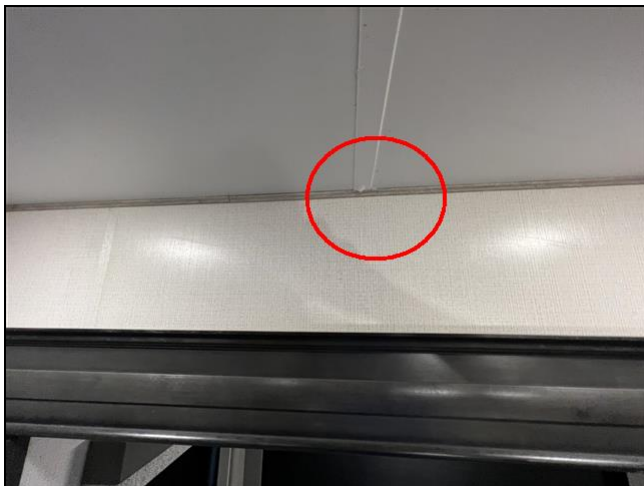
Above fireplace

(1) There area areas throughout the kitchen living room, that have tearing trim molding and nail holes.

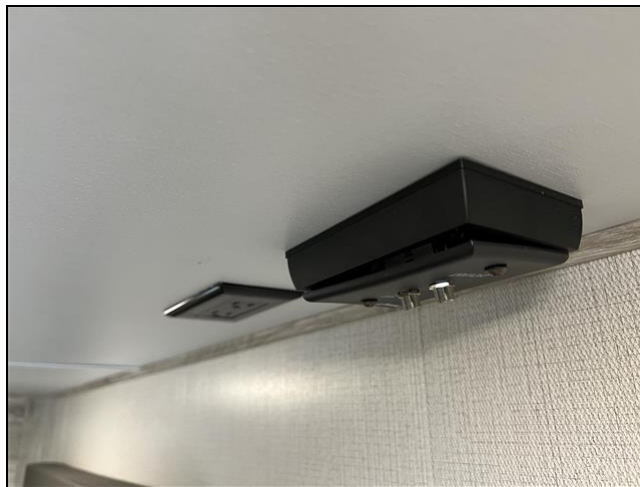
(2) Cable box in master bedroom coming down from ceiling.

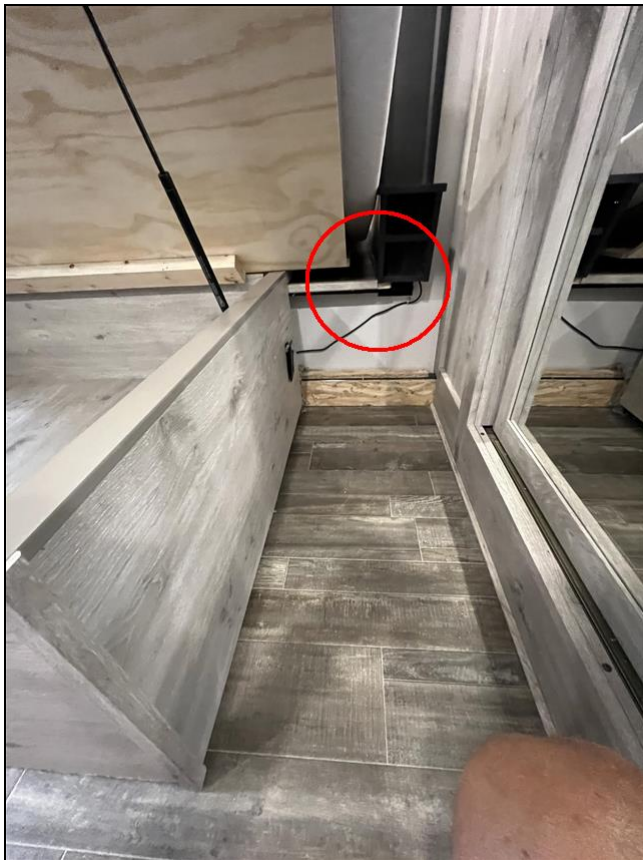
Right side of master bed

(1) There are holes in walls on both sides of the master bed, where you can see light coming through from the outside. This could lead to water intrusion.

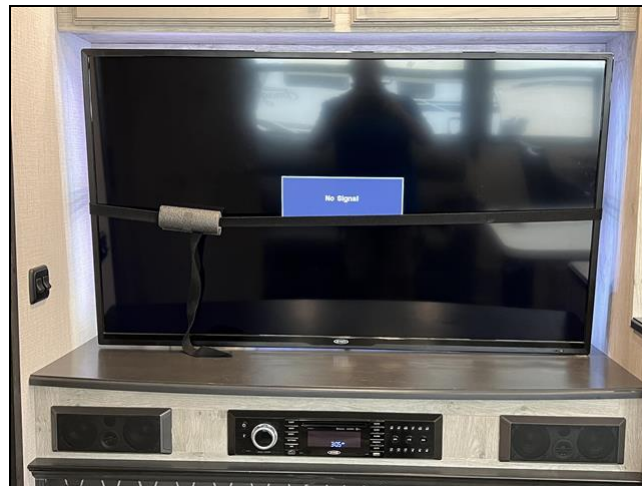
Unable to determine if it was mounted properly do to a strap on the tv.
