RV Inspection Report

2006 Winnebago Voyage 35A

VIN Number: VIN#5B4MP67GX63414371

TNT RV Inspections

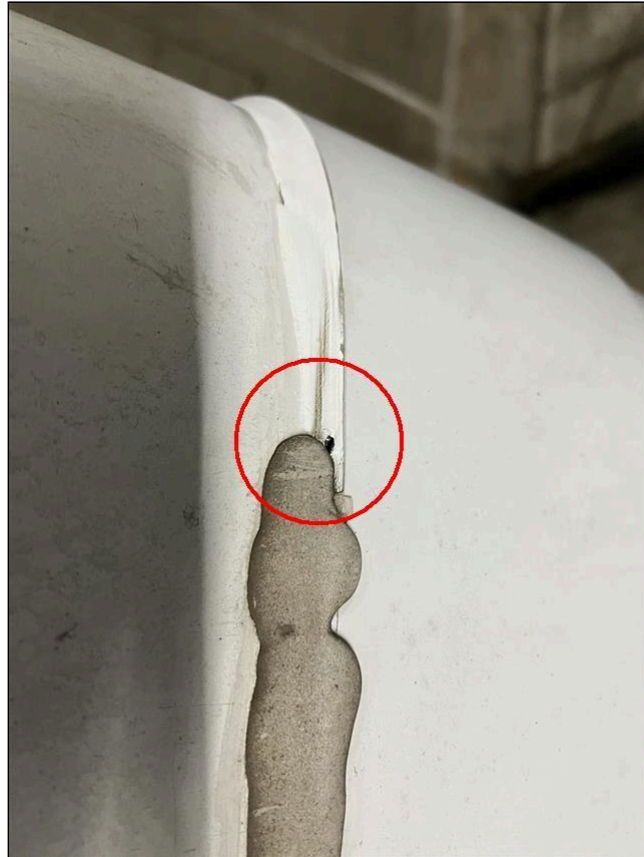
There is a small hole in sealant about 5 inches from sidewall, which could lead to the possibility of water getting in.

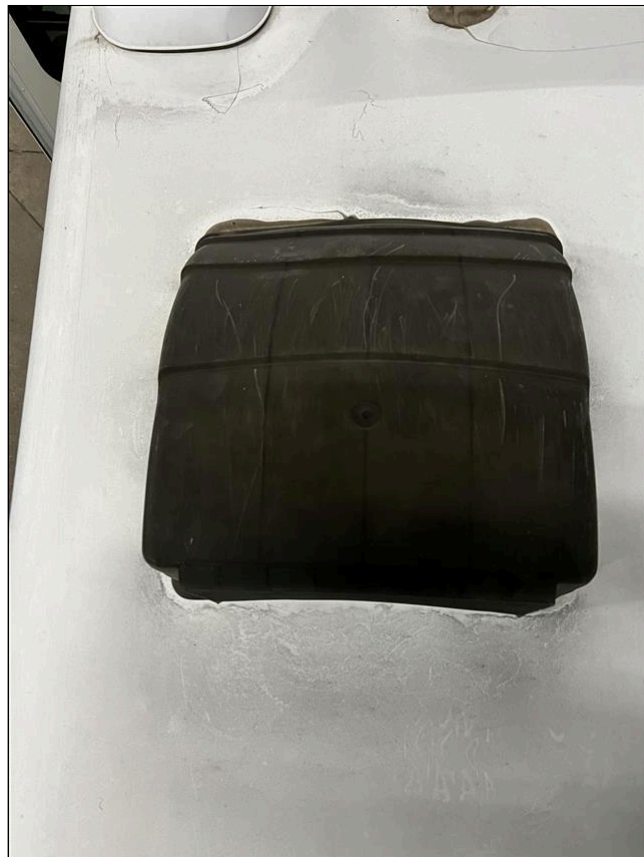
🔧 Front vent cover had a crack that is about 6 inches in length.

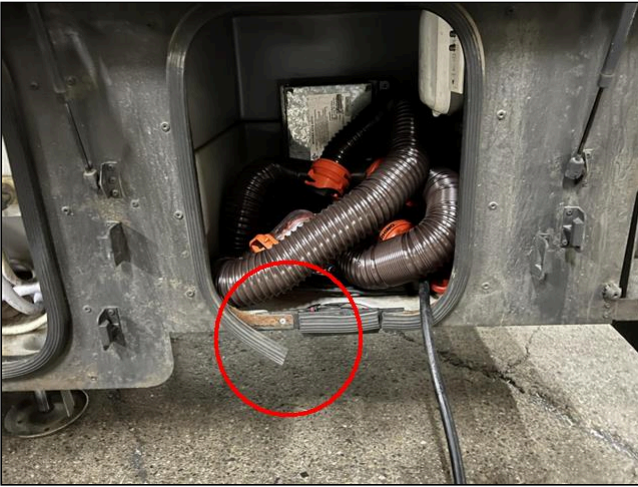
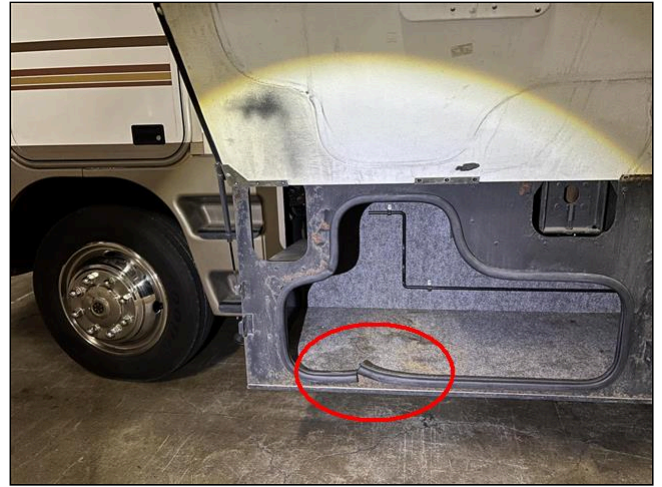
Front cargo door

(1) Some of the seals around 2 of the doors are coming undone. The front most door is beginning to separate and leaving a large hole between outer wall and inside wall.

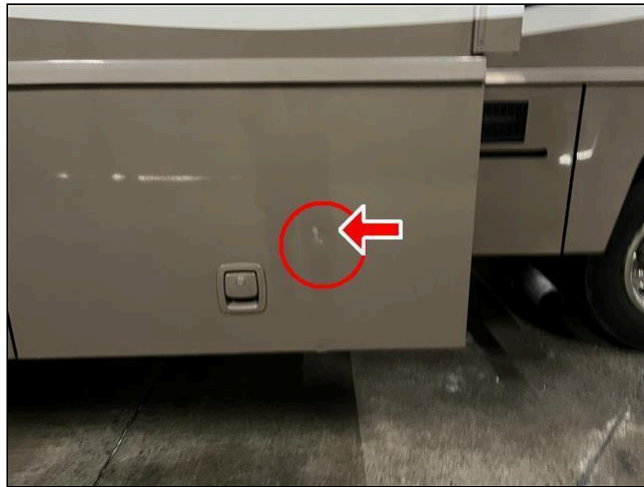
(2) There is a dent in the first cargo door in front of the streetside drive axel.

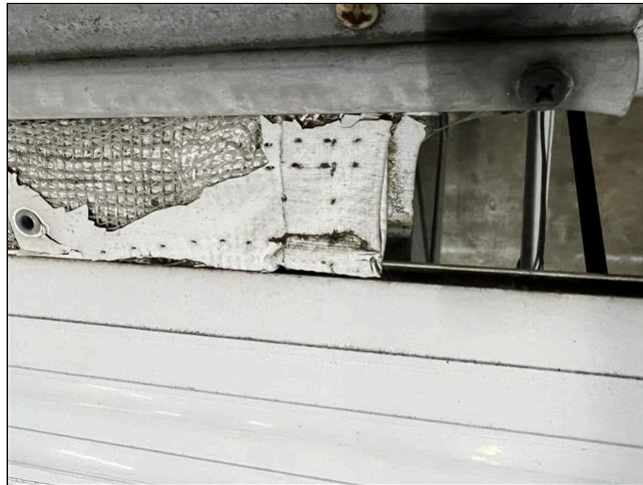
- 🔧 (1) The left and right side of the awning fabric edge is beginning to tear and crack.
- 🔧 (2) Fabric that holds the awning cover to the roof is deteriorating and beginning to tear.

(2) Fabric that holds the awning cover to the roof in deteriorating and beginning to tear.

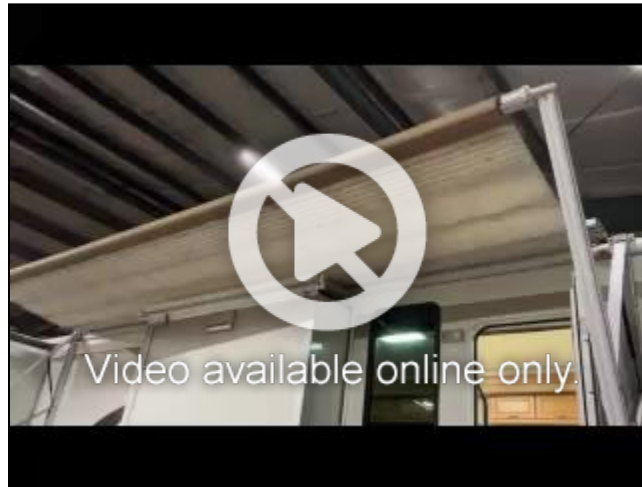
Video of awning retracting.

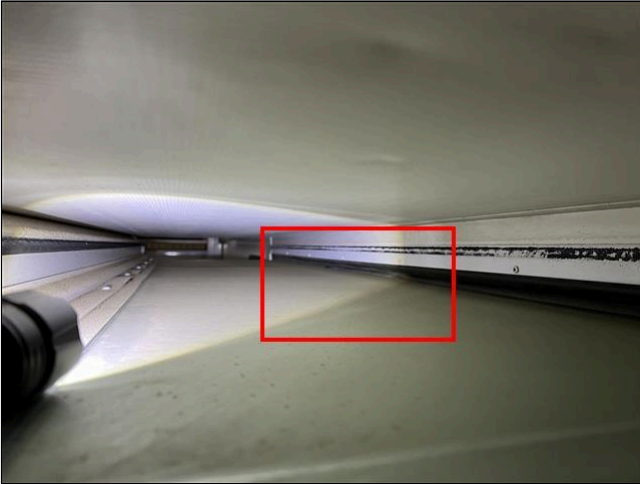
The upper sweep is not working as intended. The lower left bubble seal has been flattened out and not working as intended.

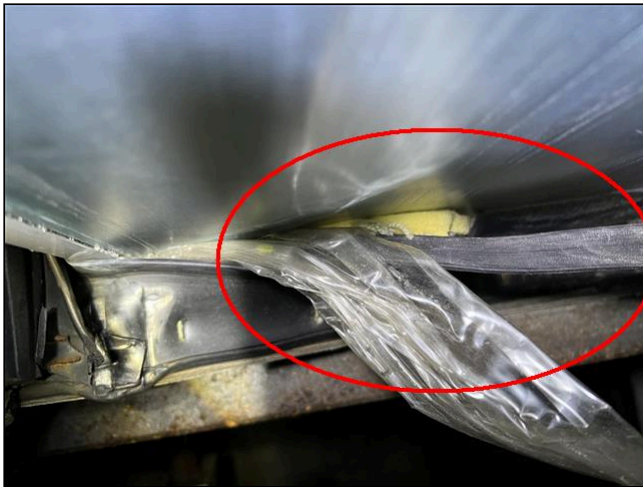
7.2.C Seals, Sweeps and Gaskets
Comments: Fair

🔧 Left rear sweep where it meets the sidewall is torn.

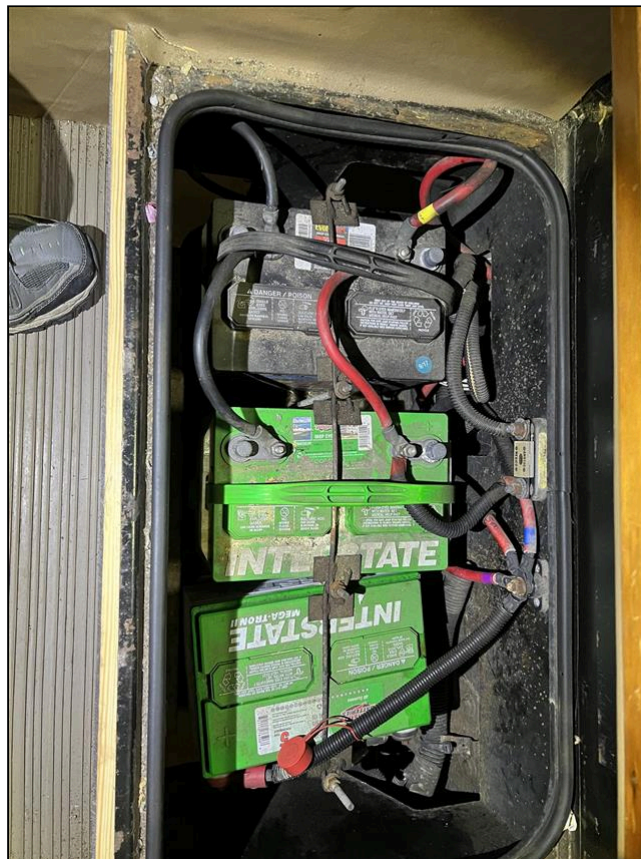
There were 3 different size house batteries.

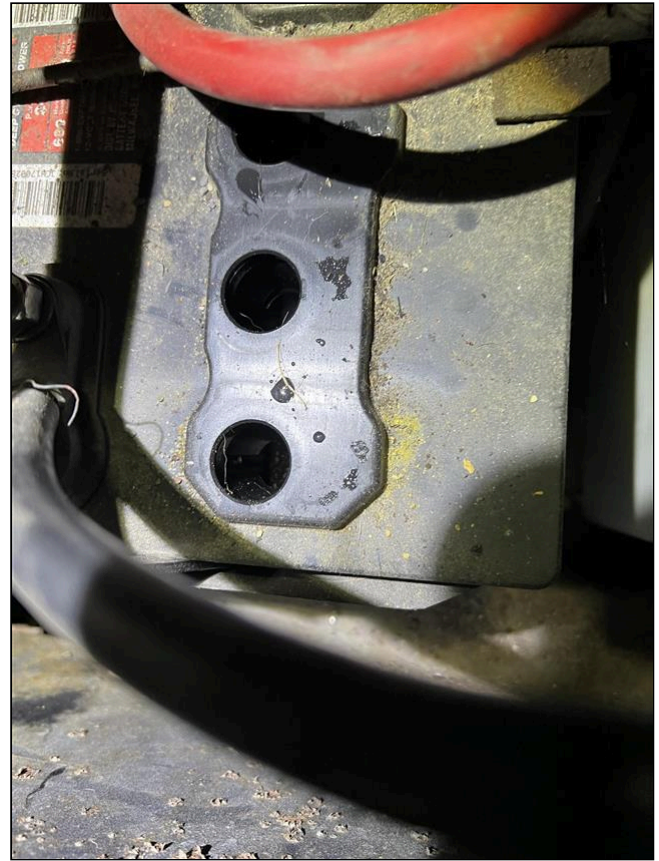
Two of the three batteries the water level was either unable to be seen or extremely low.

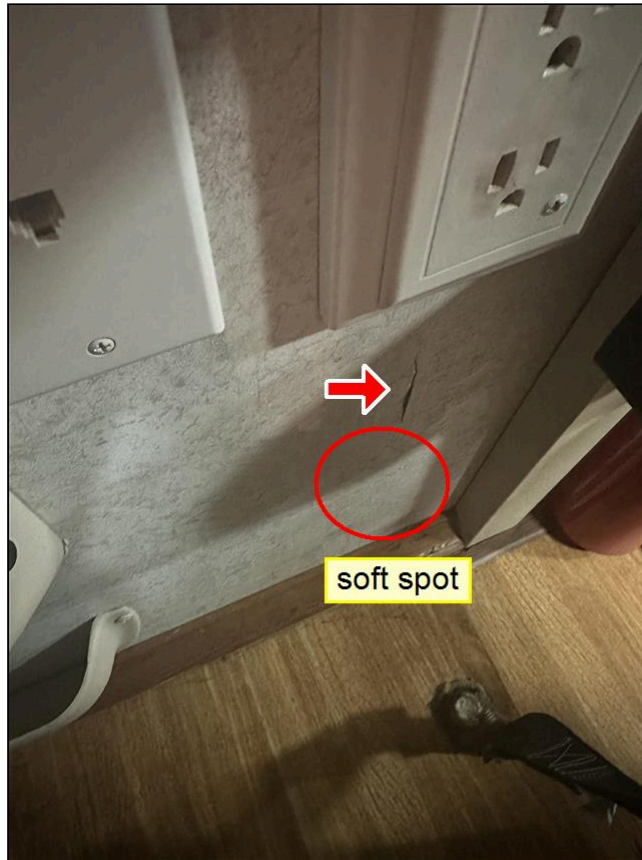
- (1) There is a tear in wall fabric and a small soft spot alongside of passengers front chair.

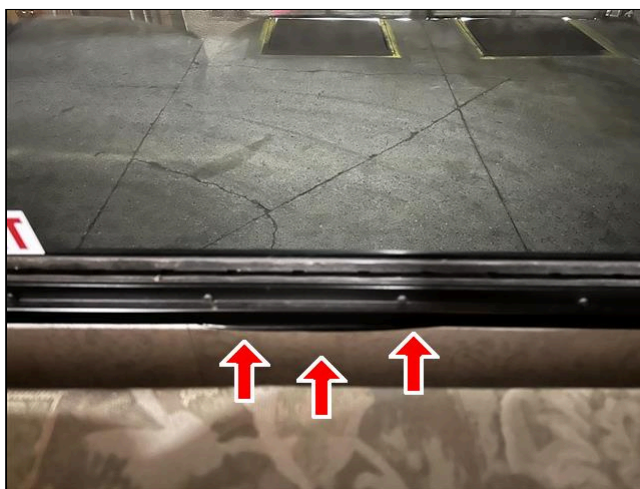
(3) Seal at bottom of window over couch is coming out.
